Technical Service Bulletin

91 Drive select, ACC, cruise control, navigation, Bluetooth, smartphone interface, or voice recognition not available

91 16 64 2042506/3 July 26, 2016. Supersedes Technical Service Bulletin Group 91 number 16-37 dated April 14, 2016 for reasons listed below.

Model(s)	Year	VIN Range	Vehicle-Specific Equipment
A3	2015 - 2018	All	Not Applicable
A4, Q7, R8	2017 - 2018	All	Not Applicable
A6, A7, TT	2016 - 2018	All	Not Applicable

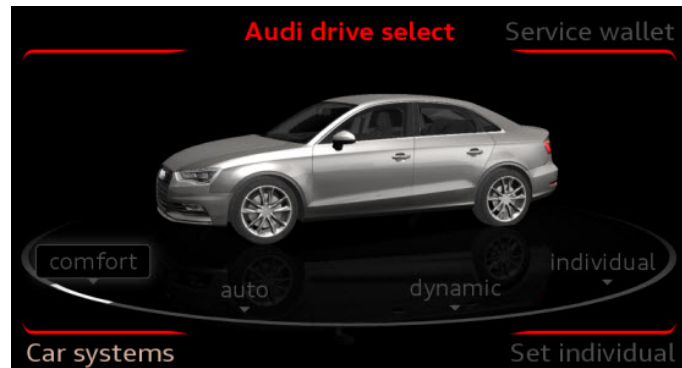
- Audi drive select functions cannot be selected (Figure 1).
- Cruise control does not work (in A3, TT, R8, B9, or Q7 only) and **DTC P161200** (ECM incorrect coding) is stored in one or more of the control units on the Powertrain CAN bus (address word 03 (ABS), address word 01 (ECM), etc.).
- Navigation is not activated (Figure 2 and Figure 3).
- Bluetooth is unavailable.
- Audi smartphone interface, including CarPlay or Android Auto, is not available.
- Voice recognition is unavailable (in all cars except A3 cabriolet. For A3 cabriolet, see TSB 2038136).

Figure 1. Audi drive select functions unavailable and greyed-out.

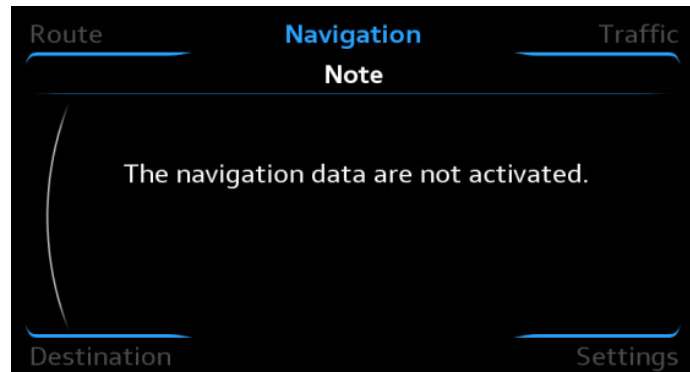
Figure 2. Navigation not activated message (Original MIB HMI)

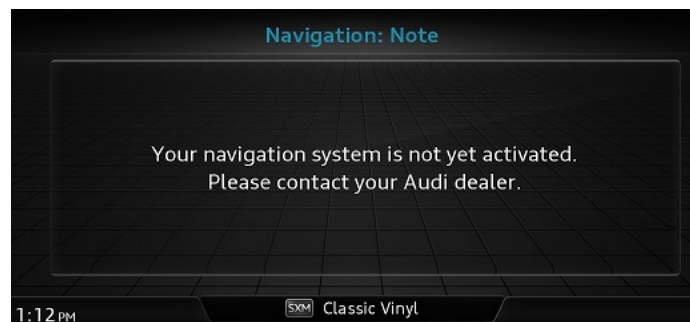
Figure 3. Navigation not activated message (New MIB2 HMI)

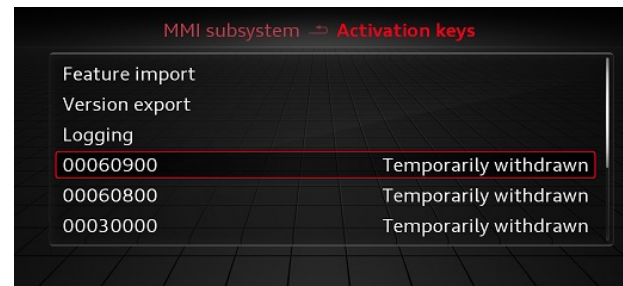
Temporarily withdrawn or Temp illegal = This indicates that the SVM activation test plan was not completed (Figure 4). This status is normal for all parts that have been swapped from a different vehicle. Perform the SVM Activations test plan as indicated below, under *Repair Procedure*.

Figure 4. Activation keys showing “Temporarily withdrawn”

1. In ODIS, run the SVM Activations test plan at *FLASH >> START FLASH >> SVM Activations >> PERFORM TEST >> -2- Obtain existing activations from server for replacement control module?* (Figure 5). This test plan will recover all activation codes for the MMI and Gateway functions.
