Technical Service Bulletin

97 Rattle noise from front right dash panel area

97 16 56 2042450/2 July 22, 2016. Supersedes Technical Service Bulletin Group 97 number 15-52 dated November 11, 2015 for reasons listed below.

Model(s)	Year	VIN Range	Vehicle-Specific Equipment
A6, A7	2011 - 2017	All	Not Applicable

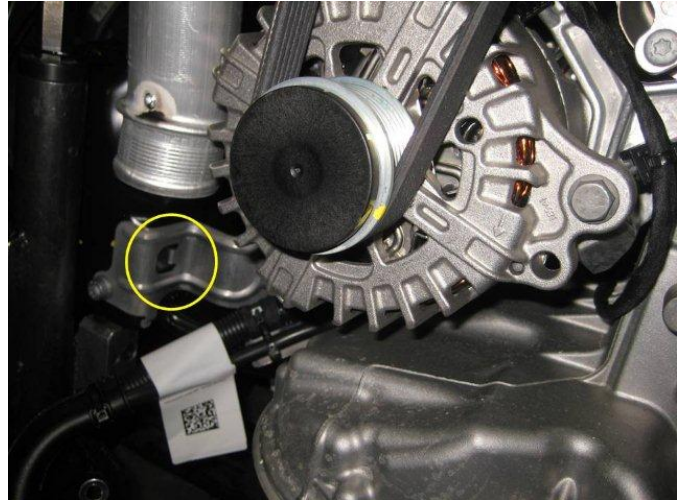
A rattling noise is heard from the right dash panel area when the car is driven with light acceleration (between 15 mph and 25 mph).

The bracket for the starter motor wiring harness has a locating tab that can vibrate.

Figure 1. Location of the wiring harness bracket.

1. Remove the bracket for the starter motor wiring harness. The bracket is located near the alternator (Figure 1).

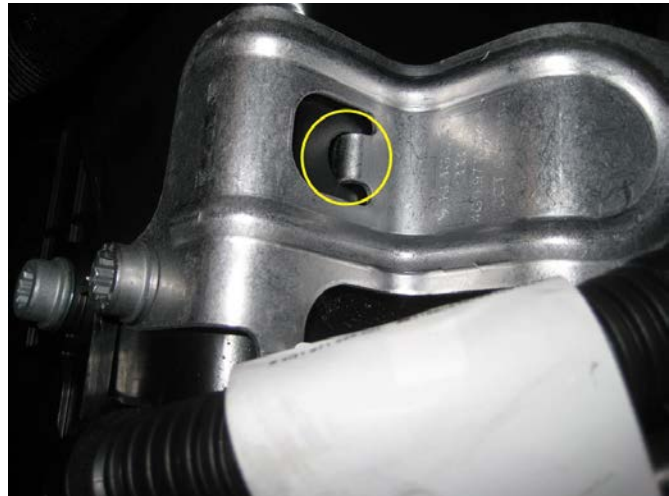
Figure 2. Locating tab before it has been wrapped with tape.

2. Wrap a 3" piece of fabric adhesive tape (D 373125A2) around the locating tab to prevent it from moving freely (Figure 2 and Figure 3).

The tape should be wrapped around the tab approximately four times so that it fits firmly in the hole. There will be some resistance when the wrapped tab is put back in the hole.

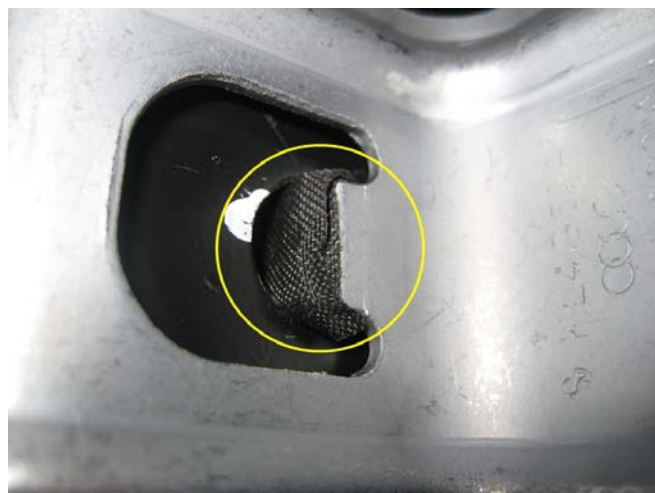
Figure 3. Locating tab after it has been wrapped with tape.

3. Reinstall the bracket.
