Technical Service Bulletin

70 Rattle noise in left front dash from head-up display

70 16 53 2044763/1 July 7, 2016.

Model(s)	Year	VIN Range	Vehicle-Specific Equipment
A6, A7	2011 - 2016	All	Head-up display

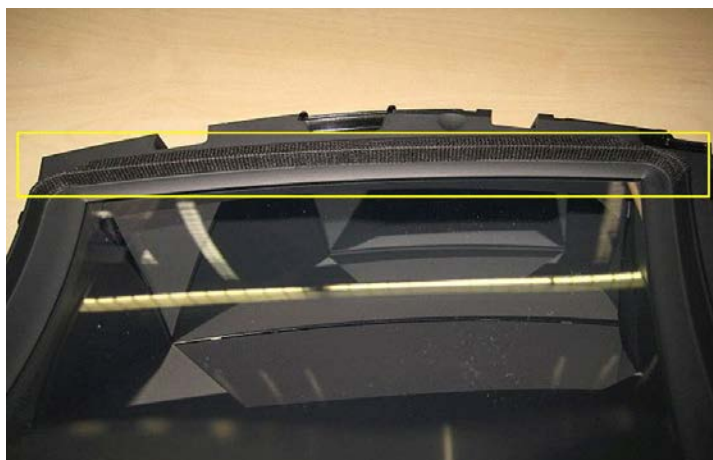
When the vehicle is driven over poor road surfaces, creaking or rattling noises can be heard from the upper dash panel on the driver's side.

The upper and lower head-up display trim pieces are making contact, which causes the noise.

Figure 1. Placement of textile tape.

Cover the trim of the head-up display with textile tape (part number D 373125A2), as shown (Figure 1). Ensure that the tape completely covers the edge of the trim.
