# Technical Service Bulletin

## 87 Faint noise heard in cabin from air conditioning circuit

87 16 75 2044717/1 July 8, 2016

Model(s)	Year	VIN Range	Vehicle-Specific Equipment
A6, A7	2012 - 2015	All	2.0L or 3.0L gas engine

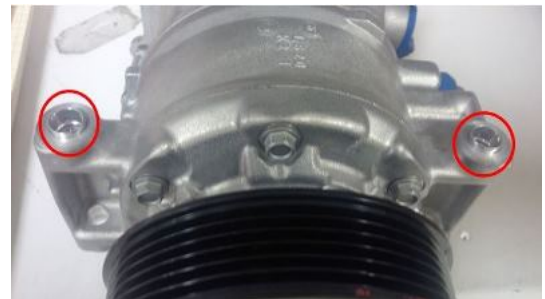
**Figure 3.** Mounting bolt centering sleeves on the air conditioning compressor housing.

It is imperative that the compressor mounting bolt centering sleeves be reinstalled with the compressor (Figure 3). Failure to reinstall these sleeves will result in compressor failure (as well as possible engine and/or ancillary component damage) in a short period of time. If any sleeves were misplaced during the removal and reinstallation process, new sleeves should be ordered and installed on the compressor housing before reassembly. Compressor or consequential component damage resulting from a failure to install the centering sleeves will not be accepted under warranty.

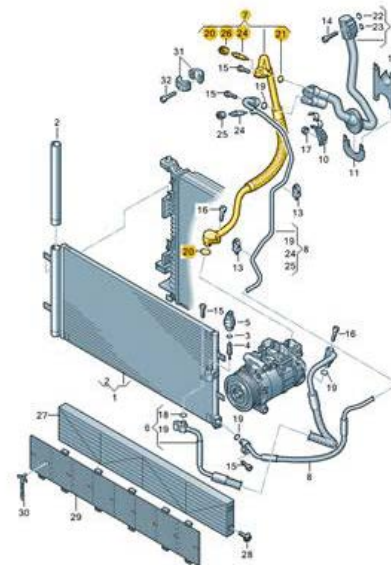
**Figure 4.** Low side line to be replaced.

3. Replace the low side refrigerant line that connects the air conditioning compressor suction port to the hybrid refrigerant line to the expansion valve (Figure 4). Be certain to use new O-rings at these and all refrigerant circuit joints that are disconnected.

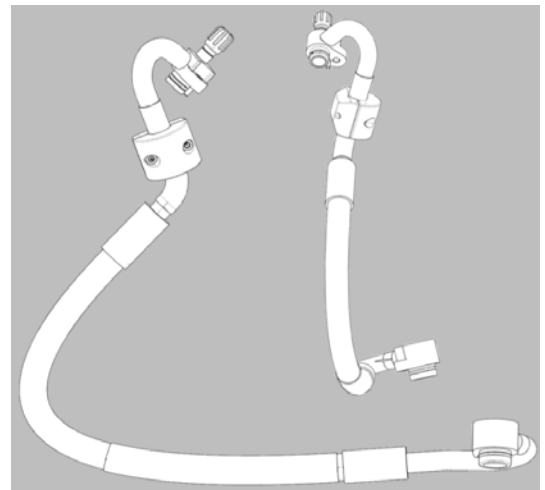
**Figure 5.** Balance weight position on low side line.

4. Install the balance weight (part number 4G0513621A) to the line in the position shown in the illustration (Figure 5).
