# Technical Service Bulletin

## 90 Instrument cluster: driver information system or backlighting inoperative

90 16 69 2044859/1 July 15, 2016.

Model(s)	Year	VIN Range	Vehicle-Specific Equipment
A4	2017	000001 - 009171	Not applicable

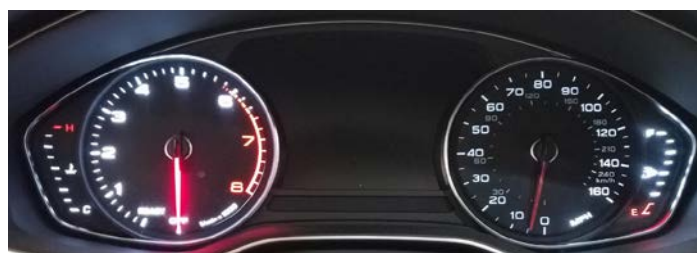
- One or both of the following conditions is present:
  - The driver information display (DIS) in the instrument cluster is inoperative (Figure 1).
  - The backlighting of one or multiple portions of the instrument cluster is inoperative (Figure 1).
- No DTCs are stored the instrument cluster control module, J285 (address word 17)

**Figure 1.** Example of inoperative driver information display with inoperative backlighting.

The hardware of the instrument cluster needs to be updated. The updated hardware optimizes the driver information display.

1. Before proceeding, check the vehicle fault memory in GFF to ensure that no DTCs are stored in the instrument cluster control module, J285 (address word 17). If related DTCs are found, this bulletin does not apply. Diagnose the issue outside of this bulletin.
2. Remove the instrument cluster and check the hardware level (Figure 2):
  - If the hardware level is less than H12, replace the instrument cluster. The replacement instrument cluster must be level H12 or higher.
  - If the hardware level is H12 or higher, this bulletin does not apply. Diagnose the issue outside of this bulletin.

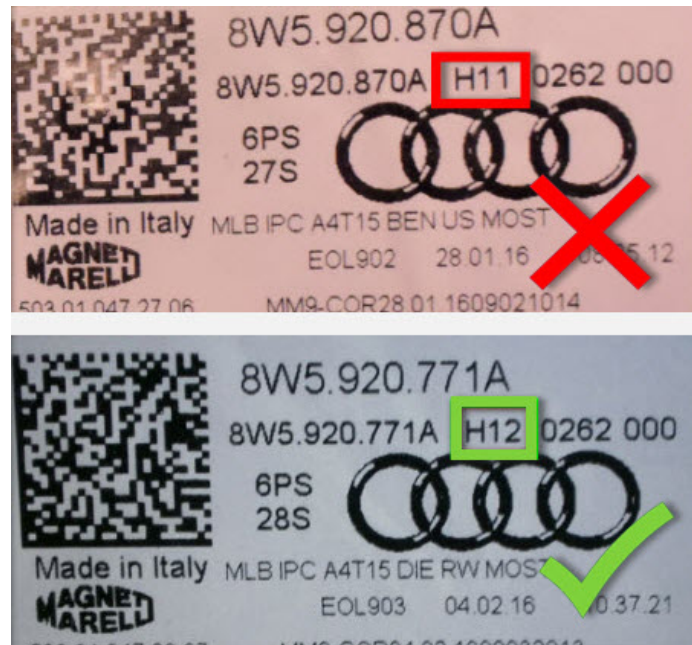
**Figure 2.** Hardware level below H12 (top) must be replaced. Hardware level H12 (bottom) does not need to be replaced.

Check ETKA for correct part number. Ensure that the replacement cluster has hardware level H12 or higher.
