Technical Service Bulletin

91 MMI3G+ Google Earth does not load after K0942 MMI software update

91 16 61 2044940/1 July 22, 2016.

Model(s)	Year	VIN Range	Vehicle-Specific Equipment
A4, A5, Q5	2013 - 2016	All	With navigation
Q7	2012 - 2016	All	With navigation

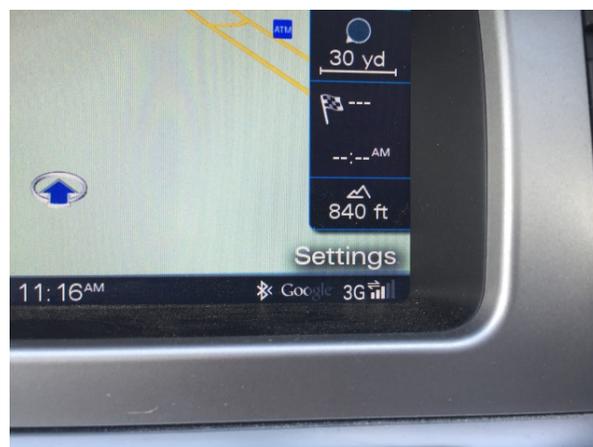
- The customer complains that Google Earth does not load in the MMI navigation map display.
- The Google icon only loads halfway, then freezes (Figure 1).

Figure 1. Google icon loads only halfway.

There is a known concern with the K0942 software update that can cause this issue. The final step of any MMI software update (ZUG update) is to document the location of where the MMI should store the customer data on the internal hard drive. The location for the Google Earth view data was incorrectly documented in this last step and created a condition where the MMI cannot store the data on the hard drive.

A software script (patch) has been developed to fix this concern and can be installed directly in the MMI via SD card. This script runs automatically and is not a ZUG update. Applying the patch does not require an ODIS tester. Only a blank SD card is required (1GB capacity is sufficient).

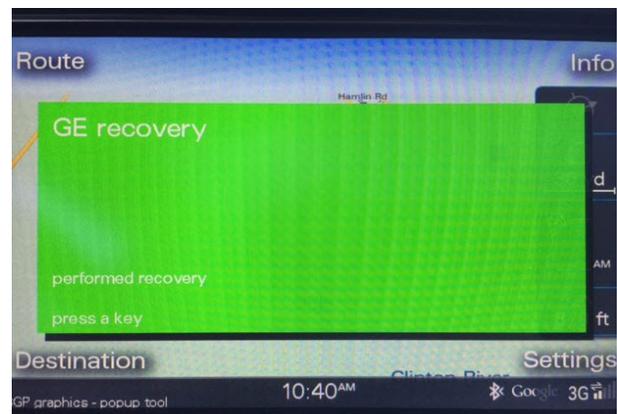
Figure 3. Confirmation screen for script

4. Allow the MMI to fully boot. Navigate to the Telephone menu and wait until all the options turn white.
5. Insert the SD card with the update files into the MMI.
6. Once the script is complete, a green confirmation screen indicating that the script has been completed will be displayed (Figure 3). If the green confirmation screen is not displayed, check the SD card to ensure that it is not damaged. Additionally, recheck the location of the file on the SD card using a computer. Repeat steps 1-3 if needed.
