2.3L GASOLINE TURBOCHARGED DIRECT INJECTION (GTDI) - HEAVY CONTINUOUS BLUE SMOKE AFTER IDLING 10 MINUTES - BUILT ON OR BEFORE 2/23/2016

TSB 16-0110

2015-2016 MKC

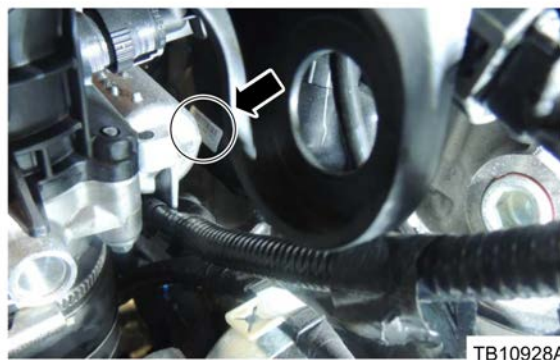
Figure 1 - Article 16-0110

1. Check the part tag on the crankcase vent oil separator using a flashlight. Look through the opening to the right of the throttle body. (Figure 1)

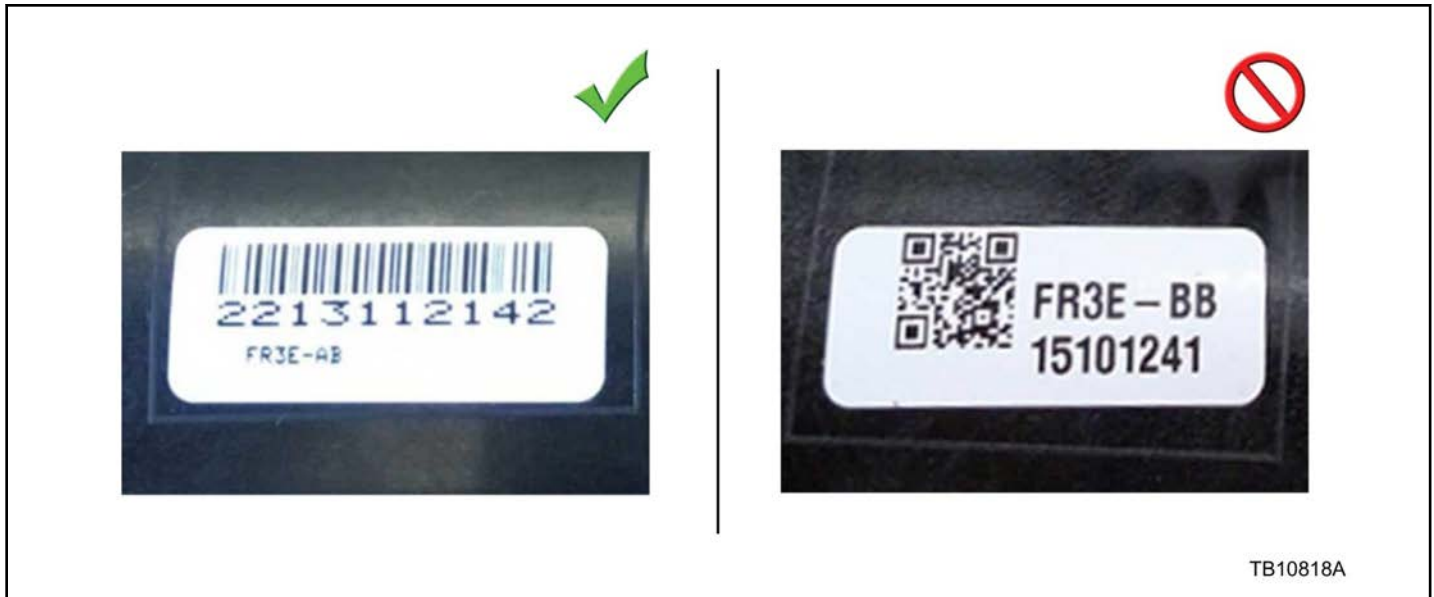
Figure 2 - Article 16-0110

2. Does the part tag have a bar code? (Figure 2)

- a. No - this article does not apply. Refer to Workshop Manual (WSM), Section 303-00 for normal diagnostics.
- b. Yes - the vehicle is not equipped with a high flow crankcase vent oil separator system. Proceed to Step 3.
- 3. Replace the crankcase vent oil separator. Refer to WSM, Section 303-08.
- 4. Reprogram the powertrain control module (PCM) to the latest calibration using IDS release 101.01 or higher. Make sure you are connected to the internet when entering module programming to obtain the latest updates. Calibration files may also be obtained at www.motorcraftservice.com
 - a. The IDS tool will require a response to the following question: Is the vehicle equipped with G1FZ-6A785-A or later crankcase vent oil separator?
 - (1) Yes - the PCM software will be updated for the high flow crankcase vent oil separator system.
