Subject: KNOCKING NOISE FROM REAR SUSPENSION WHEN DRIVING OVER ROAD BUMP	Bulletin No: 02-013/16
	Last Issued: 08/01/2016

2014-15 Mazda3 vehicles (Mexico built) with VINs lower than 3MZBM*****200038 (produced before March 2, 2015)

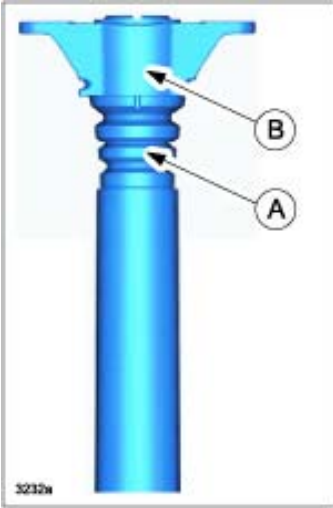
<p>30232a</p>

<p>Normal Condition: Bump stop (bound stopper) (A) is press fit and bonded to the mounting rubber (B).</p>	<p>Problem condition: Bump stop (bound stopper) is coming out of the mounting rubber.</p>

1. Verify customer concern.
2. Disassemble and assemble the affected rear shock absorber using a new bump stop (bound stopper) mounting rubber and nut according to the instructions on MS3 online (REAR SHOCK ABSORBER DISASSEMBLY/ASSEMBLY).

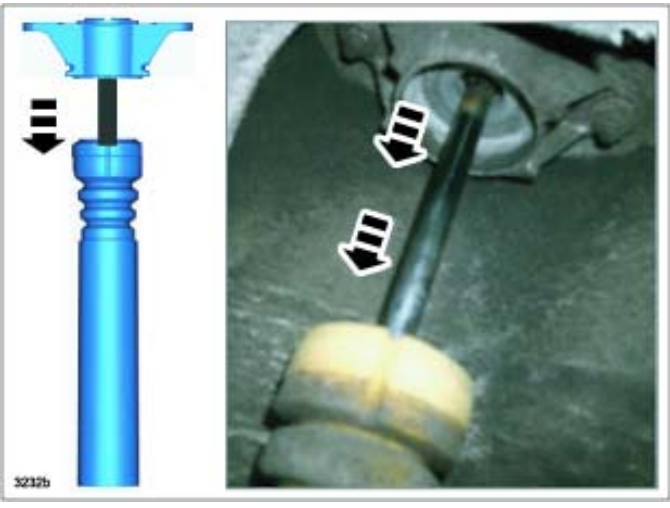
<p>30232b</p>

Some vehicles may exhibit a knocking noise from the rear of the vehicle when driving over a road bump. This may be caused by the bump stop (bound stopper) for the rear shock absorber coming out of the mounting rubber. To eliminate the concern, the bonding agent and the area to be covered have been changed to increase the bonding strength between the bump stop (bound stopper) and mounting rubber.
