Subject: AIR FROM VENTS NOT COLD WITH AIR CONDITIONER ON	Bulletin No: 07-002/16
	Last Issued: 08/04/2016

2014-15 Mazda3 vehicles (Mexico built) with VINs lower than 3MZBM*****174272 (produced before December 1, 2014)

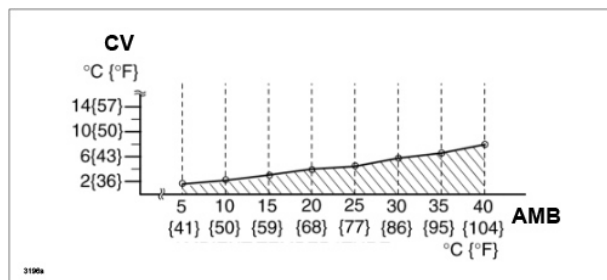
1. Verify customer concern by measuring the temperature of the air from the center vents (CV). Check to see if it is within specification of the ambient temperature (AMB) in the following chart.

- If the temperature is within specification, there is no problem with the A/C system.
- If the temperature is NOT within specification, go to next step.

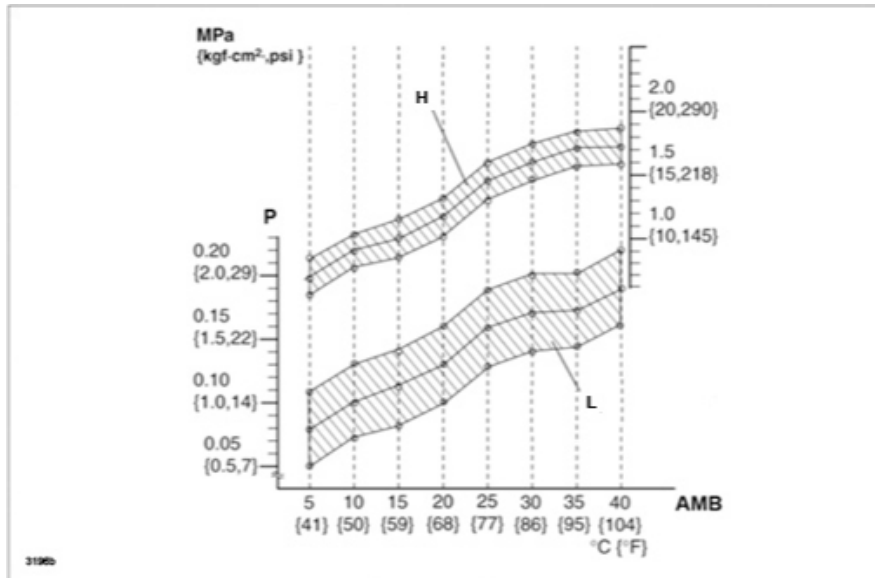
2. Perform "REFRIGERANT PRESSURE CHECK" according to the Workshop Manual . Check to see if the pressure reading of the the manifold gauge (P) is within specification of the ambient temperature (AMB) in the following chart.

- If the refrigerant high-pressure (H) is extremely high and the refrigerant low-pressure (L) is extremely low, go to next step.
 - If the refrigerant pressure is within specification, diagnose the cause using to the Workshop Manual.
 - If the refrigerant pressure is low, refill the system and inspect for the cause of the refrigerant leak.
3. Replace the whole A/C system line with new parts according to the procedures in the following sections of the Workshop Manual.
 - A/C UNIT REMOVAL/INSTALLATION
 - A/C COMPRESSOR REMOVAL/INSTALLATION
 - CONDENSER REMOVAL/INSTALLATION
 - REFRIGERANT LINE REMOVAL/INSTALLATION
 4. Verify repair.

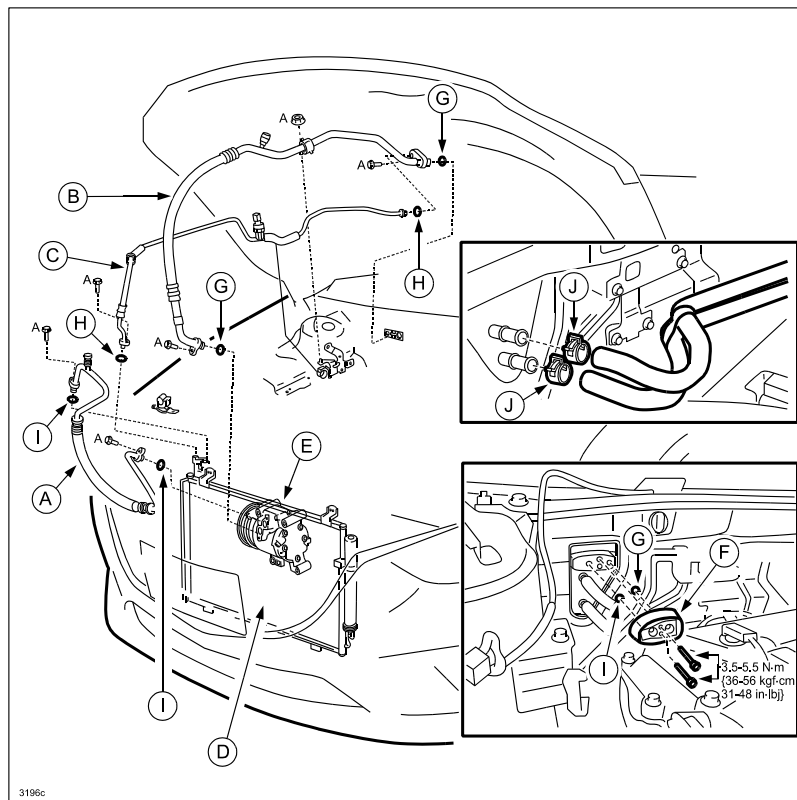
Some customers may complain that the air from the vents is not cold when the air conditioner is on. This could be caused by dust generated during polishing of the A/C pipes at production remaining in the pipes due to insufficient washing. The dust then circulates in the A/C system causing the condenser to clog and the A/C system to become inoperative. To correct the problem, the polishing process of the A/C pipes has been improved to minimize the generation of dust.

Part Number	Description	Qty.	Notes
BJS7-61-461	Flexible Hose – HIGH	1	(A) in illustration below
BJS7-61-462	Flexible Hose – LOW	1	(B) in illustration below
BJS7-61-46X	Cooler Pipe	1	(C) in illustration below
BJS8-61-480	Condenser	1	(D) in illustration below
KD45-61-450A	Compressor	1	(E) in illustration below
BJS7-61-J10	Evaporator	1	
KF03-61-J14	Expansion Valve	1	(F) in illustration below
BBM4-61-J17	O-Ring	3	(G) in illustration below
GJ6A-61-J19	O-Ring	2	(H) in illustration below
GJ6E-61-J19	O-Ring	3	(I) in illustration below
BP4K-61-242	Hose Clip	2	(J) in illustration below
