© 2016 Mazda Motor of America, Inc.

Subject: REAR CONSOLE LID DOES NOT LATCH CLOSE (BROKEN LATCH)	Bulletin No: 09-047/16
	Last Issued: 08/11/2016

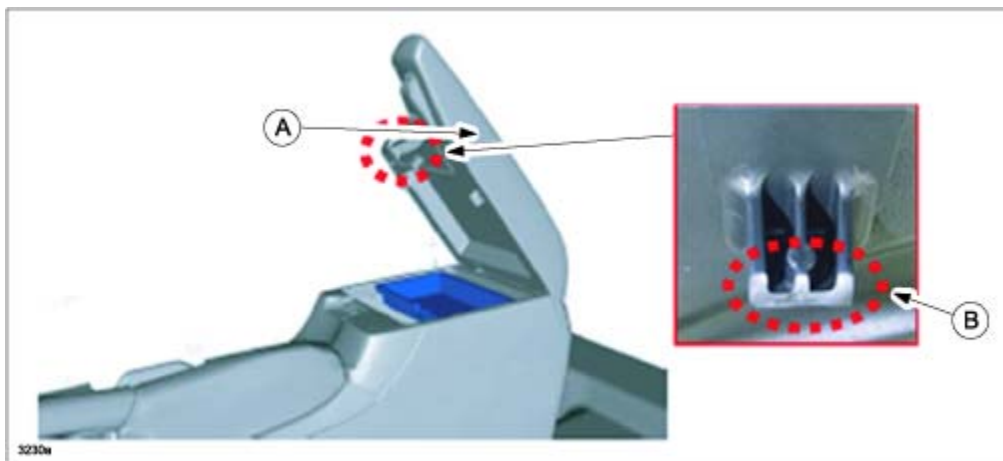
Some vehicles may exhibit the rear console lid (A) that does not latch close due to a broken latch (B). The latch may be broken by excessive external force applied to the lid. To eliminate the concern, the shape of the rear console lid latch has been changed to increase the strength.
