Subject: SQUEAKING NOISE FROM FRONT CONSOLE WHILE DRIVING ON ROUGH ROADS	Bulletin No: 09-048/16
	Last Issued: 08/12/2016

2016 CX-9 vehicles with VINs lower than JM3TC*****114514 (produced before July 18, 2016)

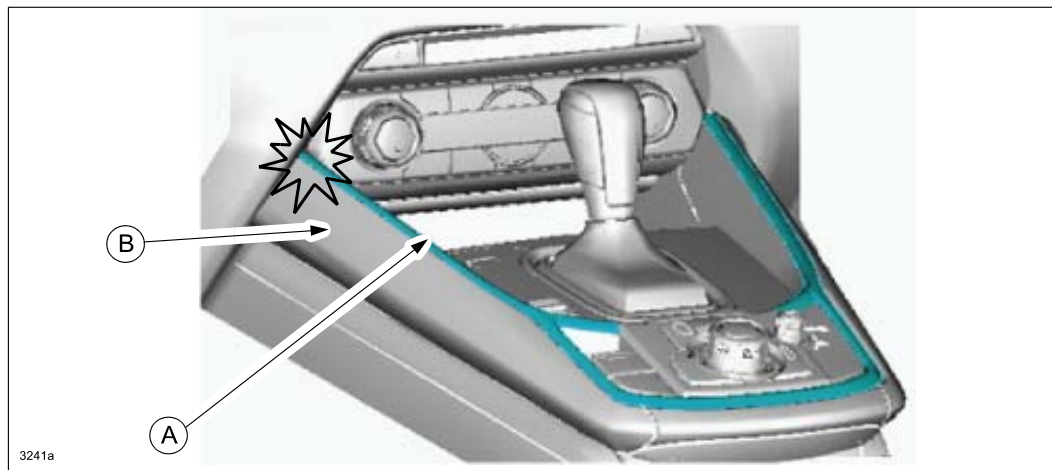
Some vehicles may exhibit a squeaking noise from the left and/or right side front console panels when driving on rough roads. The noise can also be reproduced by pushing the side panel at the location shown below.

The noise may be caused by the chrome decoration panel (A) interfering with the side panel (B). To eliminate the noise, a noise prevention tape has been added to the front console.

Customers having this concern should have their vehicle repaired using the following repair procedure.
