Subject: CREAK NOISE FROM REAR OF VEHICLE WHEN CLUTCH IS ENGAGED QUICKLY OR VEHICLE ACCELERATES/DECELERATES RAPIDLY	Bulletin No: 05-006/16
	Last Issued: 08/23/2016

2016 MX-5 vehicles with VINs lower than JM1ND*****106639 (produced before October 5, 2015)

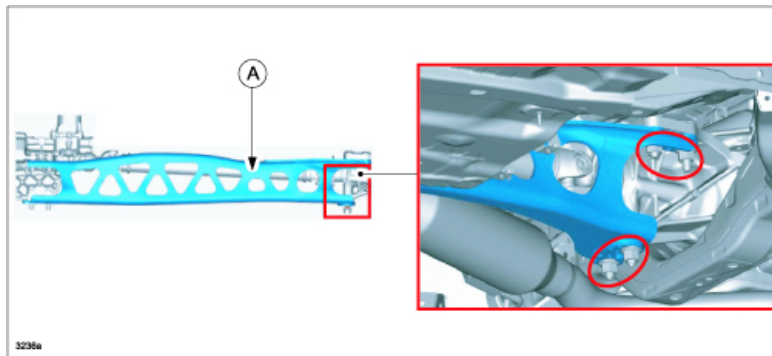
Some vehicles may exhibit a creak noise from around the rear differential when the clutch is engaged quickly or the vehicle accelerates/decelerates rapidly. This is caused by a stick-slip noise occurring at the contact surface between the power plant frame (PPF) (A) and the rear differential. To eliminate this concern, the tightening torque of the stud bolts and nuts has been increased.
