Subject: OIL SEEPAGE FROM REAR SHOCK ABSORBER(S)	Bulletin No: 02-014/16
	Last Issued: 08/25/2016

2016 CX-3 vehicles with VINs lower than JM1 DK ***** 100396 (produced before April 6, 2015)

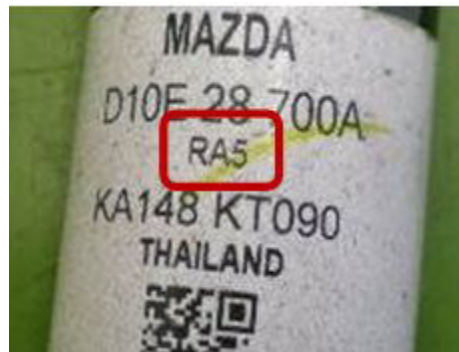
1. Safely raise the vehicle on the hoist.
2. Check the label on both rear shock absorbers for the lot number (example: RA5 is the lot number shown in the illustration below). If the lot numbers are within the production range shown in the table below, replace the rear shock absorbers with new ones.

Applicable lot number:	SK3 (3rd week of November, 2014) through RB1 (1st week of February, 2015).
Lot number reading:	Example: "RA5" means 5th week of January, 2015.
1st letter:	Year: S = 2014, R = 2015, Q = 2016
2nd letter:	Month: A = Jan., B = Feb., C = Mar.,.....K = Nov., L = Dec.
3rd letter:	Week: 1 = 1st week, 2 = 2nd week, 3 = 3rd week, 4 = 4th week, 5 = 5th week

3. If the lot number on the shock absorber label is “SK3” through “RB1”, replace the rear shock absorber according to the instructions on MS3 online (REAR SHOCK ABSORBER REMOVAL/INSTALLATION).

- Replace only the affected side rear shock absorber.
- Replace the shock absorber and the nut.
