<b>Subject:</b>  DASHBOARD UPPER PANEL WARPING	<b>Bulletin No:</b> 09-050/16
	<b>Last Issued:</b> 08/30/2016

2010-2013 Mazda3 vehicles with VINs between JM1 BL \*\*\*\*\* 324925 to 778739 (before January 12, 2013).

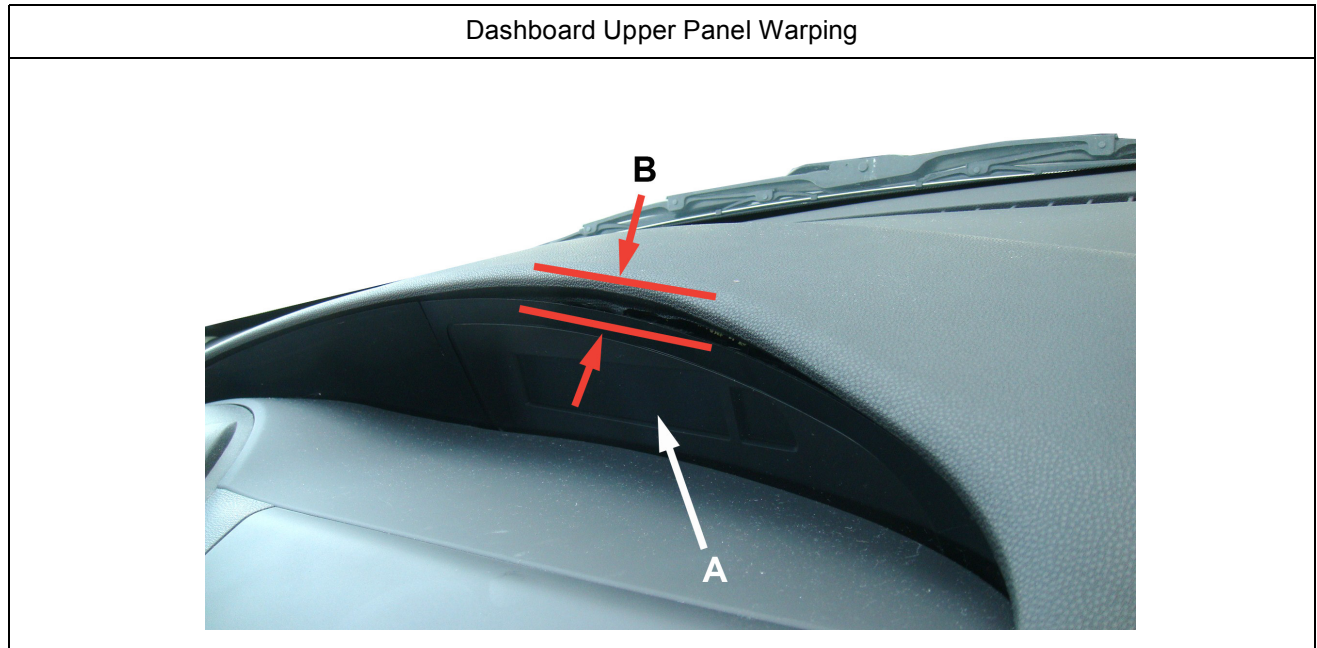
Some customers may complain about the dashboard upper panel just above the information display (A) is warping, generating a gap (B):

Customers having this concern should have their vehicle repaired using the following repair procedure.
