Subject: TPMS WARNING LIGHT ON	Bulletin No: 02-012/16
	Last Issued: 08/30/2016

2016 CX-3 AWD vehicles with VINS lower than JM1DK*****147607 (produced before June 24, 2016)

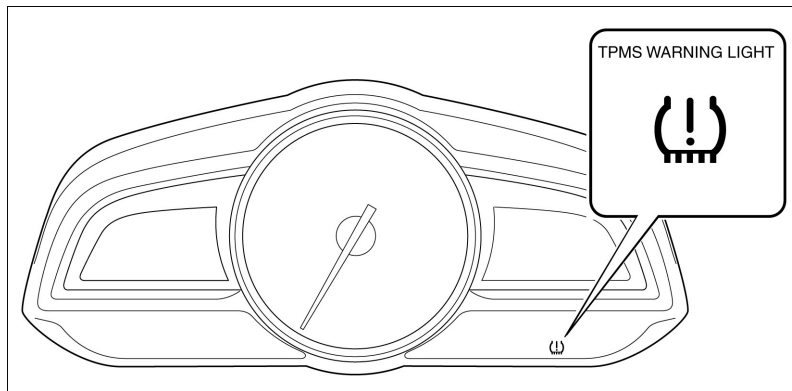
Some vehicles may experience a Tire Pressure Monitoring System (TPMS) warning light on when driving on a smooth road surface even if the TPMS system has been properly initialized at the specified tire air pressure.

The TPMS system may have been improperly initialized when the initialization was performed on certain types of rough road surfaces. Then, when driven on smooth road surfaces, the TPMS system may detect improper tire air pressure. The DSC HU/CM control logic has been changed for this concern.

1. Verify customer concern.
2. Are all four tire pressures at specification?
Tire Pressure Specification: Front; 36 psi, Rear; 33 psi
 - a. Yes - Go to step 3.
 - b. No - This service bulletin does not apply.
3. Replace the DSC HU/CM. Refer to MS3 Workshop Manual online DSC HU/CM REMOVAL/INSTALLATION.
NOTE: Rear brake pad replacement is necessary for proper brake system air bleeding.
4. With Mazda Modular Diagnostic System (M-MDS), perform the TPMS initialization. Refer to MS3 Workshop Manual online TIRE PRESSURE MONITORING SYSTEM INITIALIZATION PROCEDURE. This will initialize TPMS and disable the mis-use prevention logic at the same time.
5. Verify repair.
