Technical Service Bulletin

68 Squeaks and rattles from the left under dash panel

68 16 17 2044125/1 May 4, 2016.

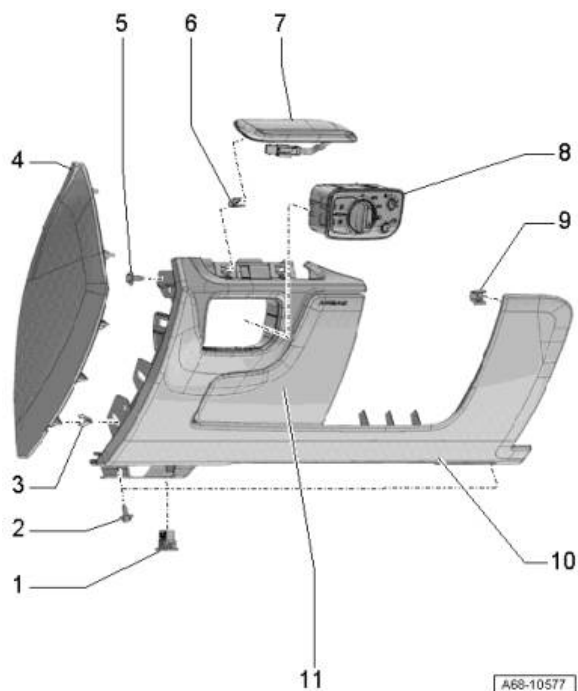
Figure 1. Left instrument panel assembly

These noises can be caused by contact between the left instrument panel cover and the adjoining surfaces of the instrument panel, or by contact between the left instrument panel cover and the footwell lamp (Figure 1).
