Technical Service Bulletin

69 DTC B102202 stored in J234 (address word 15)

69 16 29 2043919/1 May 5, 2016.

Model(s)	Year	VIN Range	Vehicle-Specific Equipment
Q7	2017	000001 - 010361	Not Applicable

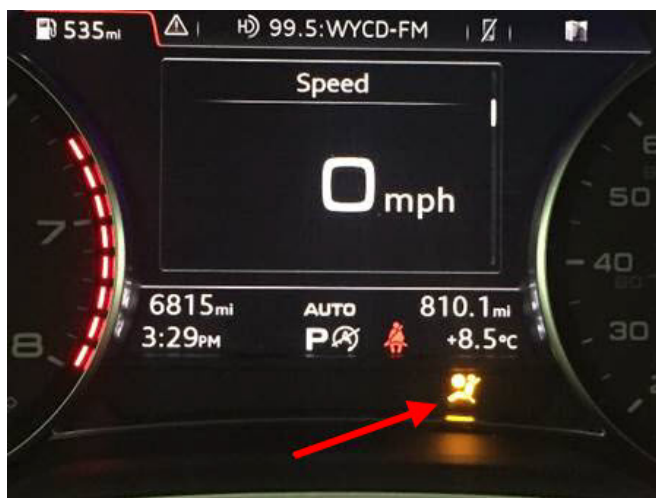
- Warning light is on in the driver information display (Figure 1).
- DTC B102202 is stored in the J234 control module (address word 15).

Figure 1. Warning light in driver information display.

If the ignition is turned on, off, and on again within a specific time frame, it is possible to set a DTC in the J234 control module. This very specific key cycle causes an interruption in the initialization, which causes fault B102202 to be stored in the J234 control module. The fault is stored as a static fault, however, the fault can be cleared with no part replacement.

1. Follow all instructions in TSB 2011732: *00 Software Version Management (SVM), operating instructions*.
2. Update the J234 control module (address word 15) using the SVM action code as listed in the table below if necessary.
