Technical Service Bulletin

91 Apple CarPlay or Android Auto complaints (blank MMI screen, no audio, does not connect, etc.)

91 16 42 2044024/1 May 6, 2016.

Model(s)	Year	VIN Range	Vehicle-Specific Equipment
A4	2017 - 2019	All	Audi smartphone interface
Q7	2017 - 2019	All	Audi smartphone interface

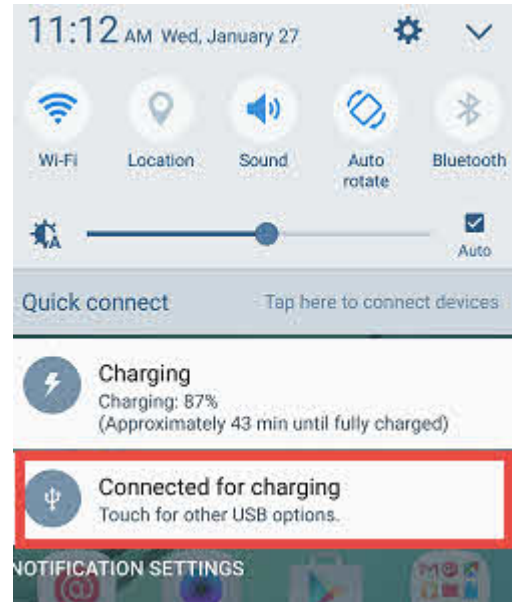
Figure 3. USB options in notification window.

Issue: Android Auto does not automatically start when the phone is connected to the USB port.

Cause: Some Android devices (including Samsung Galaxy/Note devices) require the USB MTP mode to be manually enabled after the device is connected to the USB port. This is a fault of the device firmware.

Solution: Ask the customer to manually enable USB MTP mode after connecting the device to the USB port of the vehicle.

- For most Android devices, this can be done from the notifications window from the top swipe-down menu (Figure 3).
- Find the USB notification that indicates “Connected for Charging”.
- Select this notification to bring up the USB connection options.
- Select the mode that connects as “MTP – Media Transport Protocol” (Figure 4).

Unfortunately, this process will need to be done each time the phone is connected to the vehicle or each time the vehicle is restarted with the phone connected to the USB port. Ask the customer to report the concern to the device manufacturer.

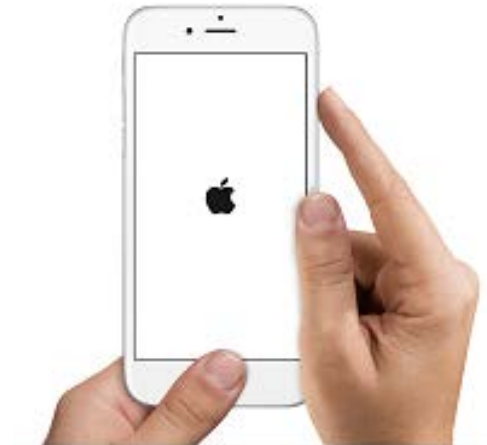
Figure 5. Force iOS reset.

Issue: Apple CarPlay does not automatically start when the phone is connected to the USB port.

Cause: Some versions of iOS have known software bugs that can cause the phone to freeze. If CarPlay does not start, ask the customer to check the phone by unlocking the phone to confirm that the top of the screen is blue and shows the CarPlay icon.

Solution: If the phone is not in a valid state with CarPlay running, ask the customer to force a restart by holding down the home and sleep/power buttons simultaneously (Figure 5) for at least ten seconds until the Apple Logo appears. This will close any misbehaving apps that may prevent the phone from being restarted using the normal shutdown method. The customer may want to consider uninstalling all non-essential apps.

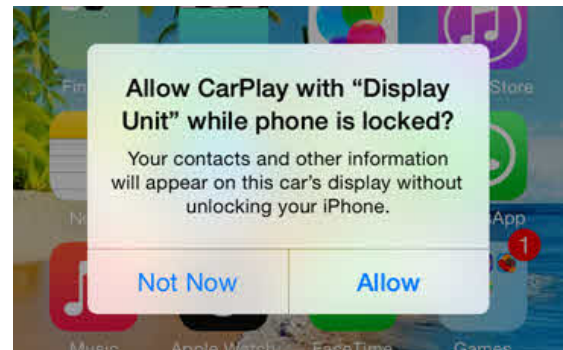
Figure 6. Allow CarPlay when screen is locked

Issue: The MMI sporadically displays an “Unlock Phone” message to allow ASI to be used.

Cause: When a new iPhone is first connected to the ASI, iOS provides a popup notification window to ask the user to allow the Audi MMI to use the iPhone while the screen is locked (Figure 6). It is easy to miss this notification window, especially if the phone is already unlocked when it is connected. If the customer does not allow CarPlay to access the phone while it is locked, the warning message will appear in the MMI every time the phone is connected (Figure 7). The customer may subsequently unlock the iPhone using the Touch ID/fingerprint sensor every time without knowing there is an option to remove this step.

Solution: Ask the customer to enable the Audi MMI to access CarPlay with the phone screen locked. To change this setting on the iPhone, go to *Settings*>>*General*>>*CarPlay*>>*Audi MMI*. Select the “(i)” next to “Audi MMI”, then select “Allow CarPlay while locked” (Figure 9).
