## 91 Noises from rear shelf when playing music

91 16 44 2044318/1 May 26, 2016.

Model(s)	Year	VIN Range	Vehicle-Specific Equipment
A3 Sedan	2015 - 2016	All	Not applicable

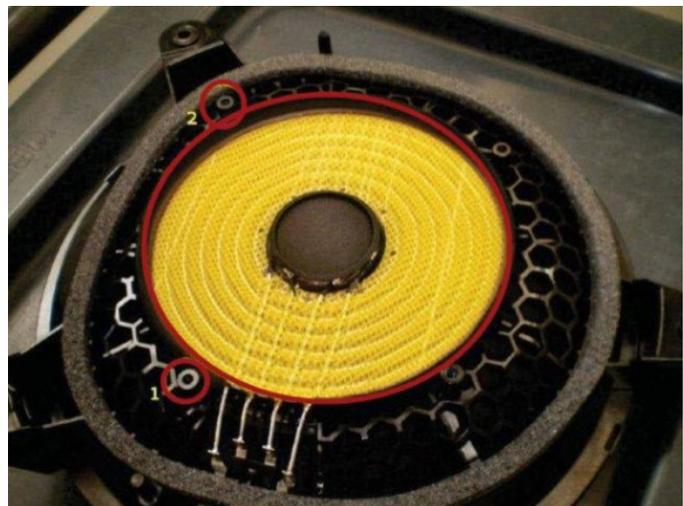
**Figure 1.** Areas on the speaker body on which to apply textile tape.

1. Remove the rear D-pillar trim, rear speaker trim, and parcel shelf trim to gain access to the rear subwoofer speaker. Remove the rear cover of the speaker and apply fleece adhesive tape (D 373125A2) to the areas shown in the illustration (Figure 1). Apply tape to both the speaker body and the protective grille.

Avoid the electrical contacts of the speaker when applying the tape.

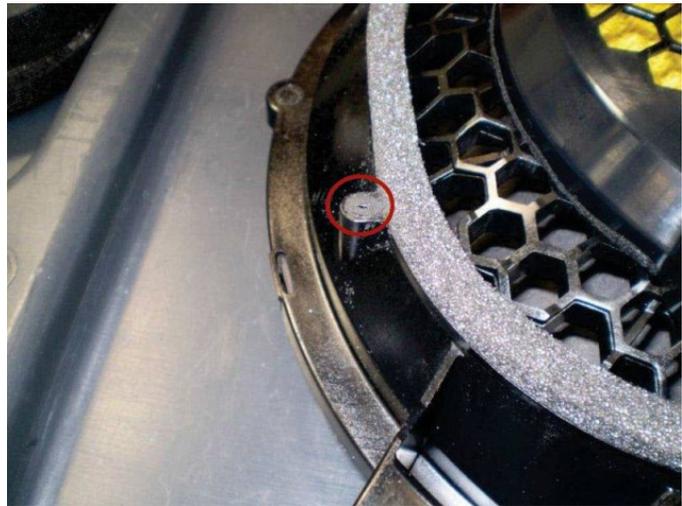
*Figure 2. Positioning pin removed.*

2. The subwoofer speaker has two positioning pins in the housing that must be cut off and ground flat (Figure 2).

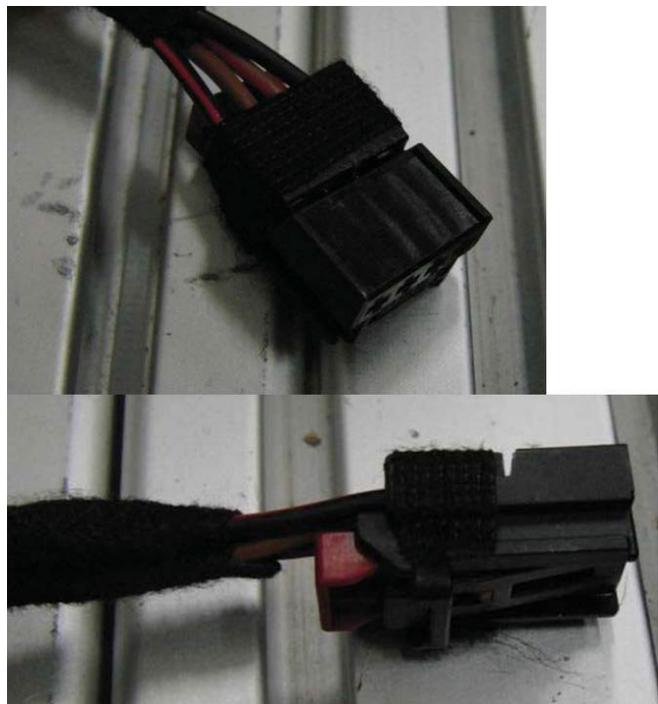
*Figure 3. Subwoofer electrical connection isolated with textile tape.*

3. Apply tape to the electrical connector as shown (Figure 3). Avoid the area of the release tang as tape in this area could compromise a sound electrical connection.

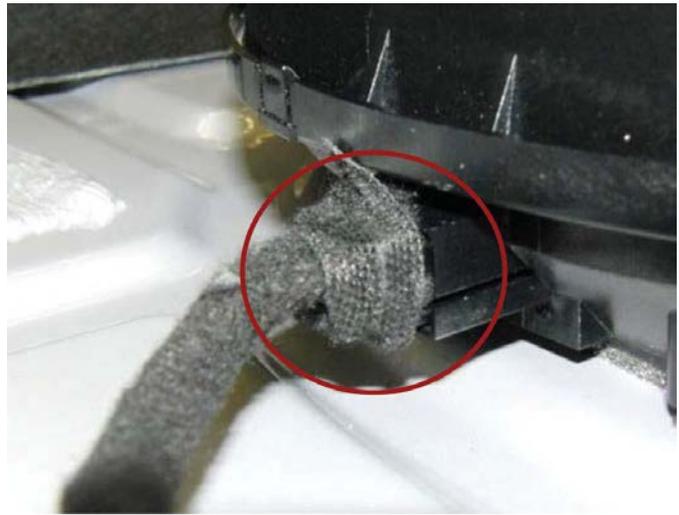
*Figure 4. Subwoofer connector isolated.*

4. After connecting the plug, isolate further as shown in the illustration (Figure 4).

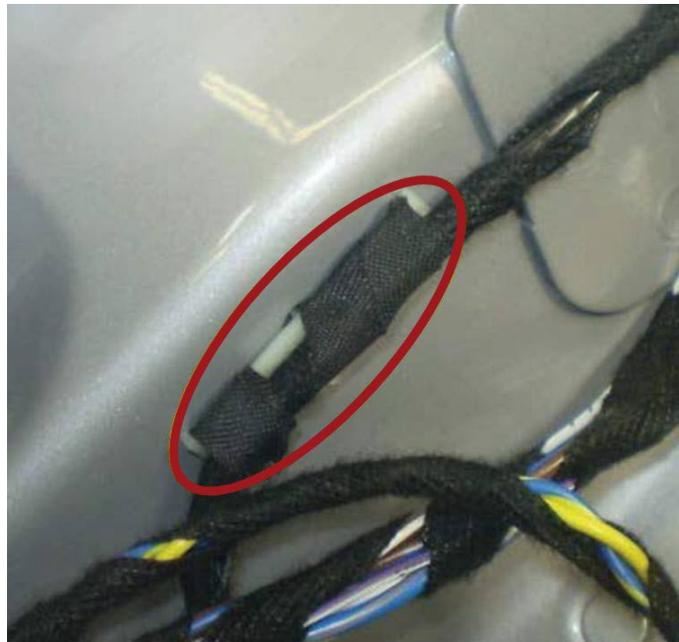
*Figure 5. Harness mounting clips isolated.*

5. Wrap the harness mounting clips in the rear shelf area (Figure 5).

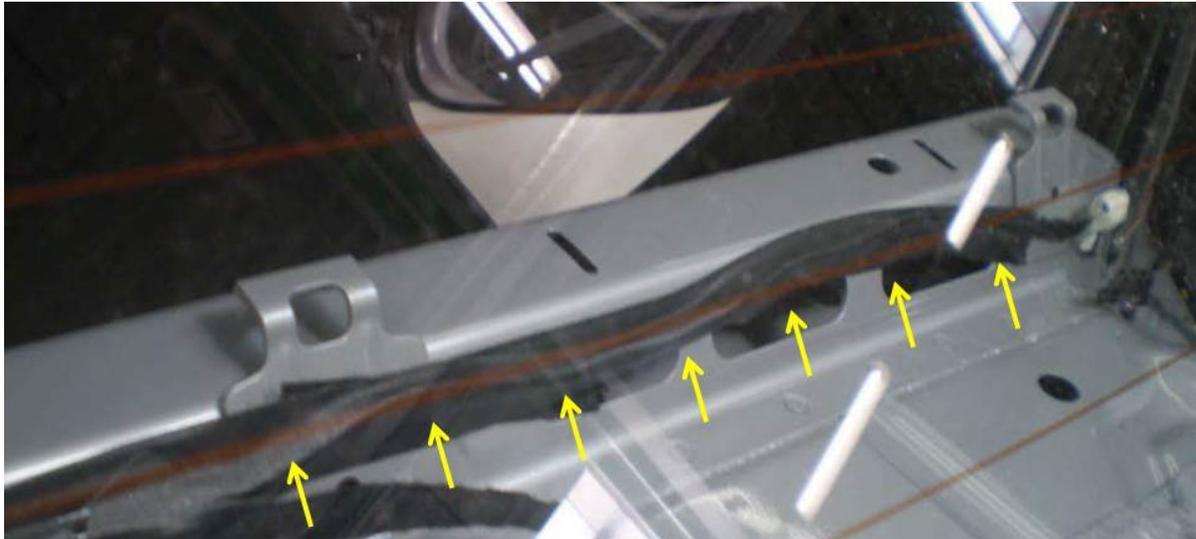
**Figure 6.** Antenna cable taped to rear shelf.

6. Using a wide textile tape, tape down the antenna cable across the rear shelf (Figure 6).
