# Service Bulletin Mazda North American Operations Irvine, CA 92618-2922

Subject: Bulletin No: 09-036/16 DOOR ARM REST POOR APPEARANCE Last Issued: 06/03/2016

2016 CX-3 vehicles with VINs lower than JM1 DK \*\*\*\*\*\* 113084 (produced before August 17, 2015)

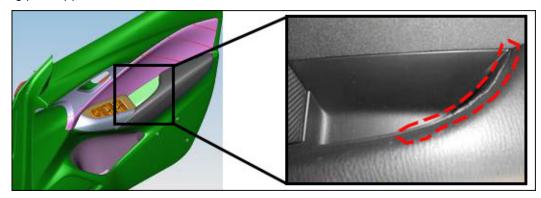
Some vehicles may exhibit a visible white felt through the gap between the front door trim and the door arm rest, causing poor appearance.

Customers having this concern should have their vehicle repaired using the following repair procedure.
