Subject: CHECK ENGINE LIGHT ON WITH DTC P0300-P0304	Bulletin No: 01-014/16
	Last Issued: 06/10/2016

APPLICABLE MODEL(S)/VINS

2013-2016 CX-5 vehicles with VINs lower than JM3KE*****802960 (produced before April 7, 2016)
 2014-2016 Mazda3 vehicles with VINs lower than JM1BM*****346088 (produced before April 7, 2016)
 2014-2016 Mazda6 vehicles with VINs lower than JM1GJ*****111093 (produced before April 7, 2016)

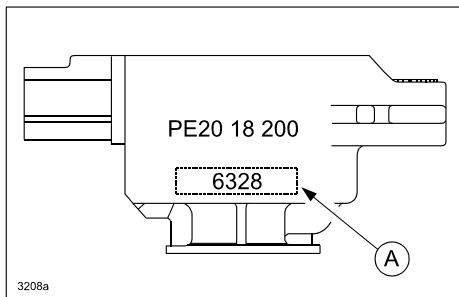
<p>3208a</p>

Some vehicles may experience a lack of engine power/rough idling and the check engine light on with one or more of the misfire related DTCs of P0300:00, P0301:00, P0302:00, P0303:00 and P0304:00. This concern may be caused by an internal failure of the ignition coil(s) due to a high difference between cold and warm ambient temperatures. The production method of the ignition coil has been changed to eliminate this concern.

NOTE: The ignition coils are supplied from two different vendors, YUMEBISHI and MITSUBISHI. This concern only occurs on YUMEBISHI- produced ignition coil.

To distinguish between YUMEBISHI and MITSUBISHI ignition coils, look at their lot numbers (A). YUMEBISHI have 4 digit lot numbers and MITSUBISHI have 5 digit lot numbers as shown.

YUMEBISHI-produced (NO GOOD)	MITSUBISHI-produced (GOOD)

3. Replace the defective ignition coil(s) with modified one(s) according to the workshop manual (section 01-18).
CX-5: IGNITION COIL/ION SENSOR REMOVAL/INSTALLATION [SKYACTIV-G 2.0, SKYACTIV-G 2.5].
Mazda3: IGNITION COIL/ION SENSOR REMOVAL/INSTALLATION [SKYACTIV-G 2.0, SKYACTIV-G 2.5].
Mazda6: IGNITION COIL/ION SENSOR REMOVAL/INSTALLATION [SKYACTIV-G 2.5].

4. Check if any of the other non-defective coils are YUMEBISHI-produced and made before lot number 6328 (March 28, 2016 production). If any were made before this date, replace them with modified one(s) as well.

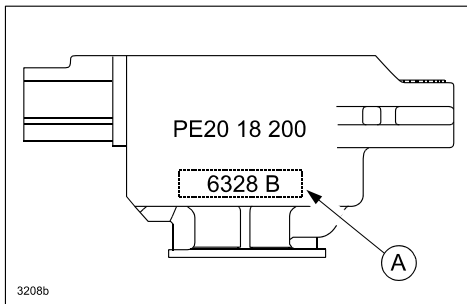
<p>3208b</p>

6	Year (4=2014, 5=2015, 6=2016)
3	Month (1=Jan, 2=Feb, 3=Mar...X=Oct, Y=Nov)
2	Day
8	
B	MITSUBISHI-produced only (A=Daytime, B=Nighttime)
