| Subject: RATTLE NOISE FROM FRONT DOOR GLASS | Bulletin No: 09-041/16 |
| | Last Issued: 06/24/2016 |

2013-2016 CX-5

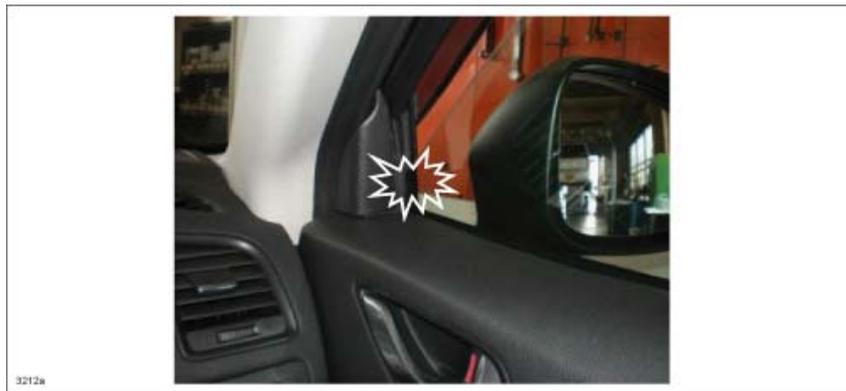
Some vehicles may experience a rattle noise from the front door glass when driving with the window open approx. 1/2 to 4 inches (1 - 10 cm).

The rattle noise may be caused by insufficient holding force of the glass run channel. To increase the holding force, the shape of glass run channel has been changed and non-woven pads have been attached to the glass run channel.
