TECHNICAL BULLETIN
JTB00493NAS2
15 JUL 2016

SECTION: 307-00

'Howl' Noise From Automatic Transmission Oil Cooler On Low-Speed Overrun

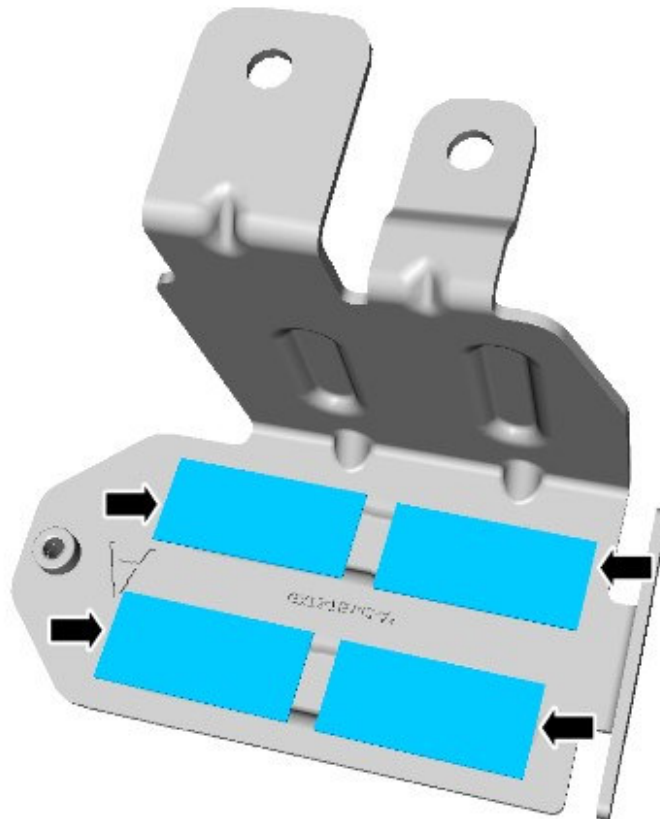
E191703

Cause: This may be caused by the automatic transmission oil cooler transmitting an oil flow noise through the front subframe which causes excessive Noise, Vibration and Harshness (NVH) into the cabin area.

7. Install the new NVH pads as shown.
