© 2016 Mazda Motor of America, Inc.

Subject: KNOCKING / SQUEAKING NOISE FROM FRONT SHOCK ABSORBER, CREAKING NOISE FROM FRONT LOWER ARM BUSHING	Bulletin No: 02-010/16
	Last Issued: 04/05/2016

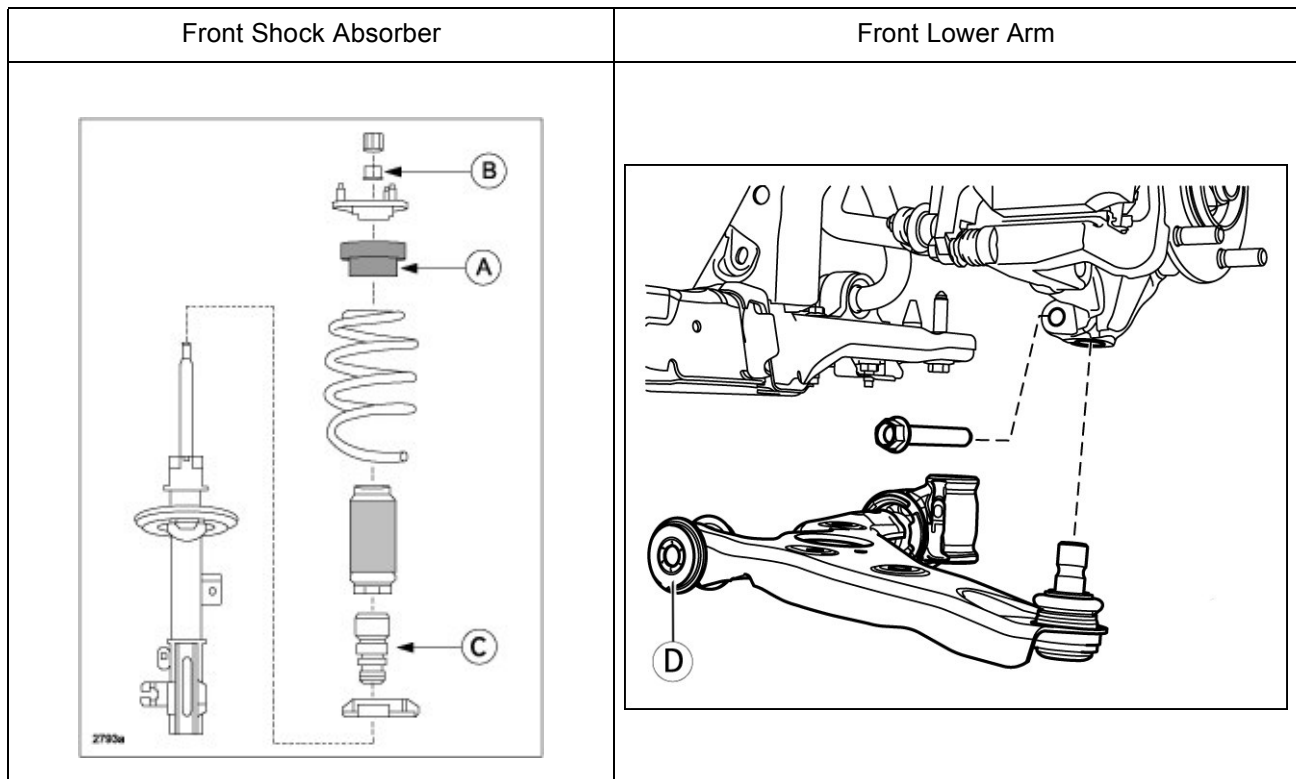
Some vehicles may exhibit a knocking / squeaking noise from the front shock absorber when driving on rough roads and/or when turning the steering wheel while the vehicle is stopped.

The noise may be due to:

- upper front strut bearing (A) damage. (CX-5 and Mazda6)
- stick/slip between the front strut bearing and coil spring. (CX-3, CX-5 and Mazda6)
- the bump stopper (C) may be contacting the strut bearing when the front shock absorber is compressed, causing a popping noise. (Mazda6 only)
- The front lower arm bushing (D) is making a stick-slip noise in wet road conditions. (CX-5 and Mazda6)

To eliminate the noise, the following mass-production changes have been made:

1. The material and production method of the front strut bearing (A) has been changed. (CX-5 and Mazda6)
2. A protector has been installed onto the coil spring. (CX-5 and Mazda6)
3. The shape of the bump stopper (C) will be modified in the future. (Mazda6 only)
4. The shape of the coil spring has been changed. (CX-3 only)
5. Friction of the lower arm bushing has been reduced by adding a dry coating. (CX-5 and Mazda6)

NOTE: The piston rod nut (B) requires replacement.

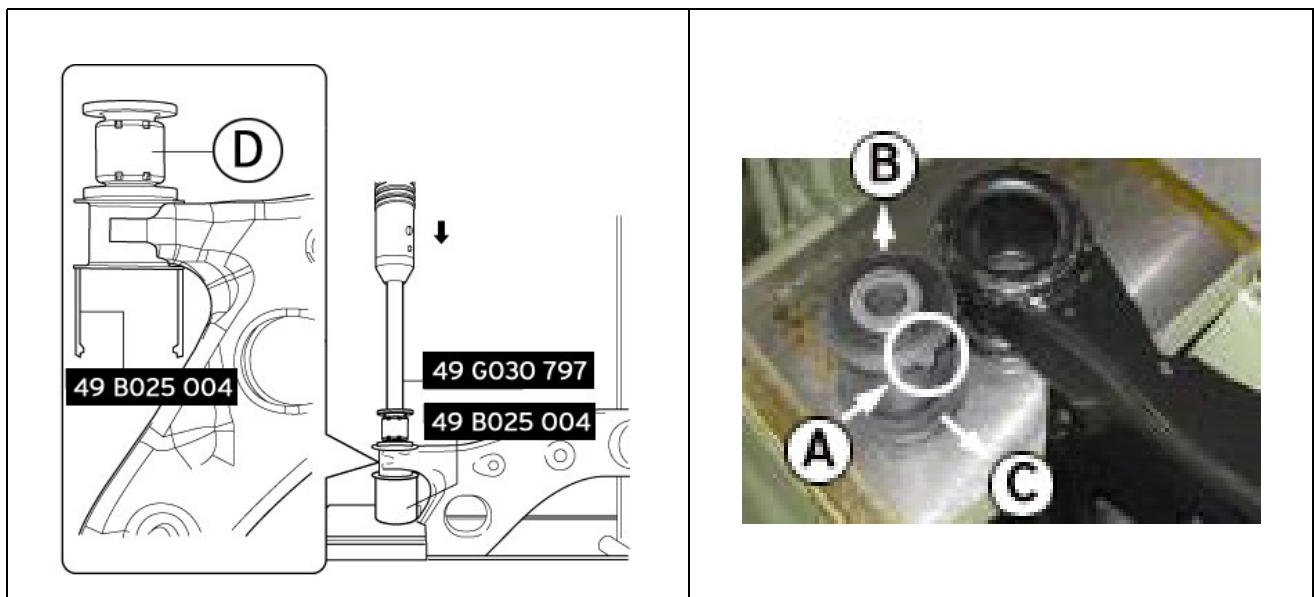
CAUTION: Make sure that the bushing has been properly inserted by checking that the tab of the bushing is completely expanded as shown in the OK illustration.

OK	NG
Tab is completely expanded	Tab is NOT completely expanded yet

3. Install the front lower arm bushing (D) using SSTs.
Install the front lower arm bushing so that the projection (A) shown in the figure is pointing toward the front (B) and out of the vehicle (C).
