Subject: SQUEAK NOISE WHEN DOOR GLASS MOVES UP AND/OR DOWN	Bulletin No: 09-023/16
	Last Issued: 04/07/2016

2016 MX-5 vehicles with VINs lower than JM1ND*****112654 (produced before February 29, 2016)

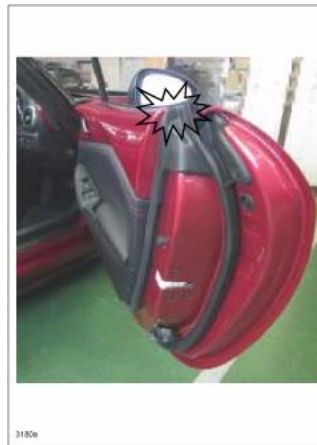
Some vehicles may exhibit a squeak noise when the door glass moves up and/or down. This concern happens especially when the door glass is wet with moisture or after a car wash.

This is caused by stick-slip noise occurring at the contact surfaces between the door glass and the weather strip. With repeated moving up and down, the anti-noise paint on the weather strip peels off. To prevent the stick-slip noise, a high slide-ability tape has been added to the weather strip.

1. Verify customer concern.
2. Remove the door trim according to the instructions on MS3 online or the Workshop Manual (section 09-17 DOOR TRIM REMOVAL/INSTALLATION).
3. Replace the weatherstrip on both doors with modified ones.
4. Install the door trim.
5. Verify repair.
