Subject: POPPING AND/OR SQUEAKING NOISE FROM FRONT SHOCK ABSORBER AND/OR CREAKING NOISE FROM FRONT LOWER ARM BUSHING	Bulletin No: 02-001/16
	Last Issued: 04/15/2016

APPLICABLE MODEL(S)/VINS

2014-2016 Mazda3 vehicles (Japan built) with VINs lower than JM1BM*****304670 (Produced before November 16, 2015)

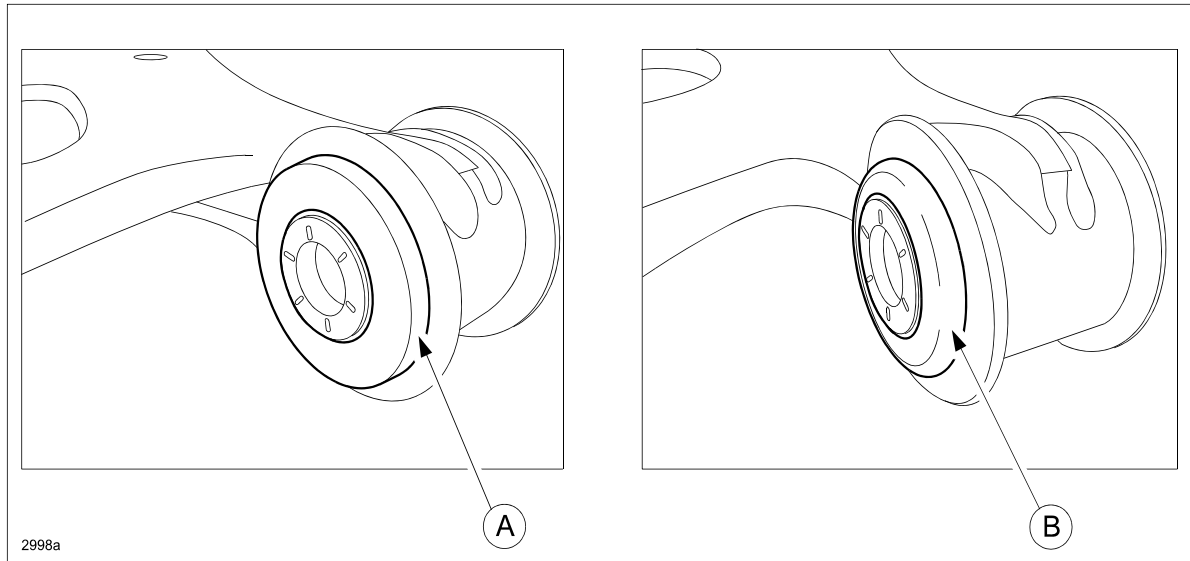
CAUTION: Make sure the bushing has been properly inserted by verifying that the bushing tab **IS FULLY EXPANDED**, as shown in the illustration to the left (A). The illustration to the right (B) shows an example of a bushing tab that **IS NOT FULLY EXPANDED**.
