Subject: MULTI-MODEL - RUST / BLISTER ON INNER SIDE OF LIFTGATE / TRUNK LID	Bulletin No: 09-027/16
	Last Issued: 04/28/2016

2010-2013 Mazda3

2013-2016 CX-5 vehicles with VINs lower than JM3KE*****800037 (produced before April 1, 2016)

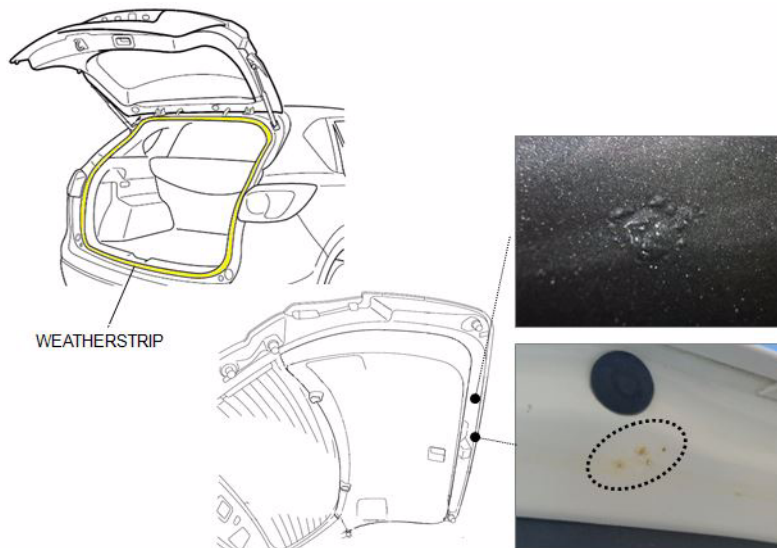
Some vehicles may exhibit rust or blistering on the inner side of the liftgate/trunk lid, where it contacts the weatherstrip (as shown below). The paint may become damaged by weatherstrip chafing caused by liftgate/trunk lid vibration while driving.

To eliminate this concern on CX-5, silicone is applied to the lip of the weatherstrip to reduce friction against the liftgate.

1. Verify the customer concern.
2. Repair and repaint the rust or blistered areas on the liftgate/trunk lid according to normal bodyshop repair practices.

- Do not replace the weatherstrip unless it is damaged.
- It is only necessary to repair affected area(s); it is not necessary to repaint the entire liftgate.
