© 2016 Mazda Motor of America, Inc.

Subject: UNUSUAL STEERING NOISE AND / OR VIBRATION WHEN TURNING	Bulletin No: 06-002/16
	Last Issued: 04/29/2016

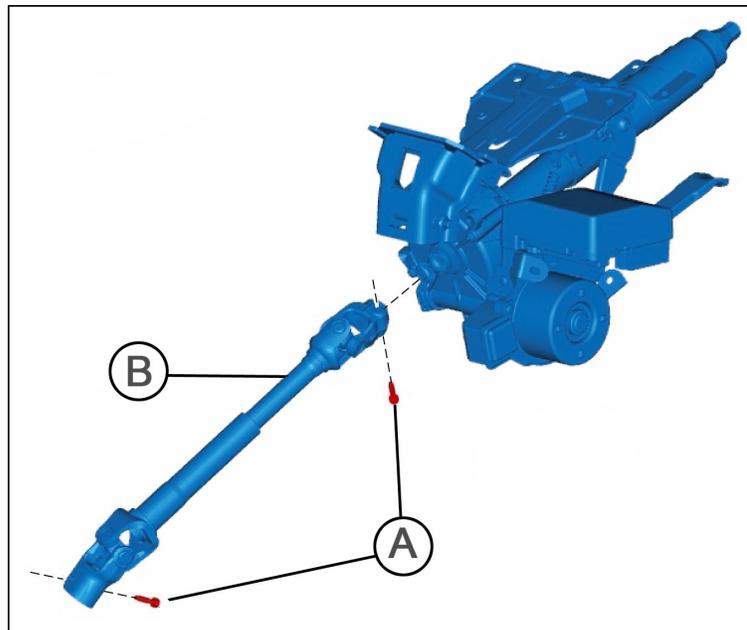
Some vehicles may exhibit an unusual noise from around the driver's foot area when repeatedly turning the steering wheel to the left or right. A vibration is felt at the steering wheel when the noise occurs.

1. Verify customer concern.
2. Replace the intermediate shaft (B). Refer to MS3 online "INTERMEDIATE SHAFT REMOVAL/INSTALLATION".

NOTE: Replace joint bolts A (Replacement part) with new ones.

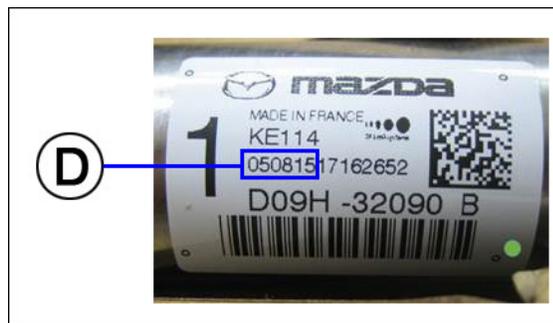
The intermediate shafts with the production date after October 28, 2015 are modified.

The image shows a production date of August 5, 2015 (D) as an example.
