Subject: RATTLE / CHATTER TYPE NOISE FROM A/C VENTS WHEN DRIVING ON ROUGH ROAD SURFACE	Bulletin No: 09-028/16
	Last Issued: 04/29/2016

2016 CX-3 vehicles with VINs lower than JM1 DK ***** 109815 (produced before July 14, 2015)

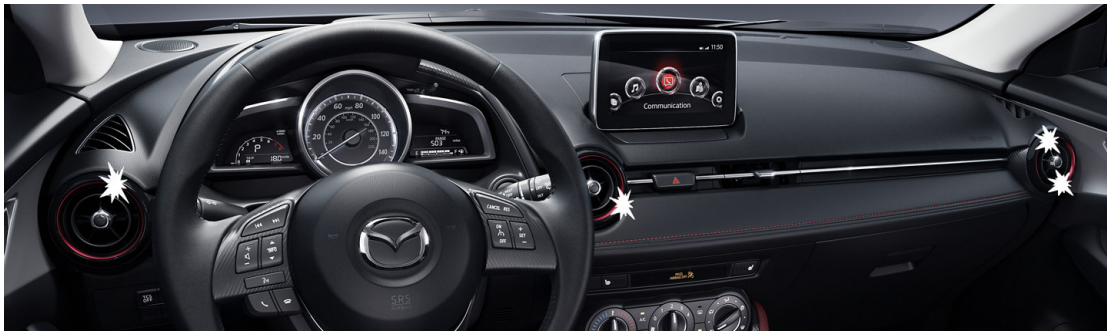
Some vehicles may exhibit a rattle/chatter type noise from the A/C vents when driving on an uneven/rough road surface.

Customers having this concern should have their vehicle repaired using the following repair procedure.
