<b>Subject:</b> <b>GRINDING NOISE WHEN OPENING AND / OR CLOSING TRUNK LID</b>	<b>Bulletin No:</b> 09-029/16
	<b>Last Issued:</b> 04/29/2016

2016 Mazda6 vehicles with VINs between JM1 GJ \*\*\*\*\* 400001 - 401811 (produced before December 11, 2014)

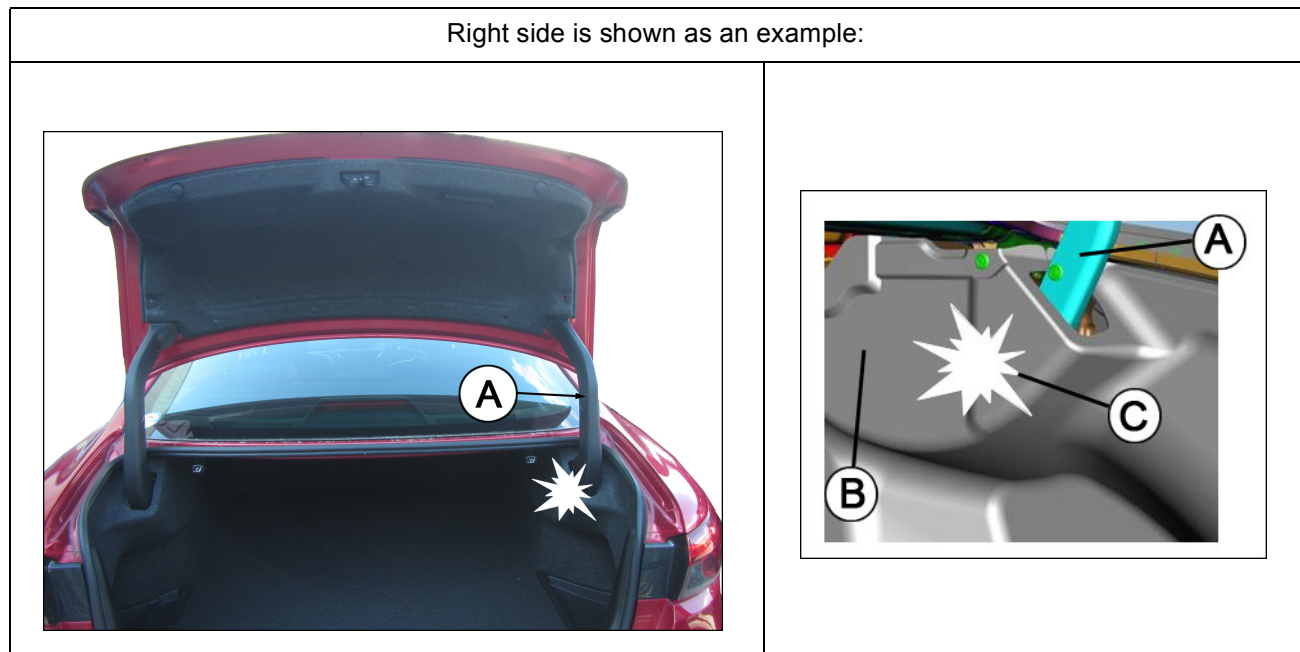
Some vehicles may exhibit a grinding type noise (C) from the trunk lid hinge (A) (one or both sides) when opening and/or closing the trunk lid. The noise may be caused by the trunk lid hinge cover (A) making contact with the trunk side trim (B).

1. Verify customer concern.
2. Replace the trunk hinge cover(s). Refer to MS3 online "TRUNK LID REMOVAL/INSTALLATION".

**NOTE:** Only replace the affected side.
