Technical Service Bulletin

21 Miscolored pipe on turbocharger

21 16 23 2034999/3 August 2, 2016. Supersedes Technical Service Bulletin Group 21 number 14-19 dated October 16, 2014 for reasons listed below.

Model(s)	Year	VIN Range	Vehicle-Specific Equipment
S6, S7, RS 7, A8, S8	2013 - 2017	All	4.0T

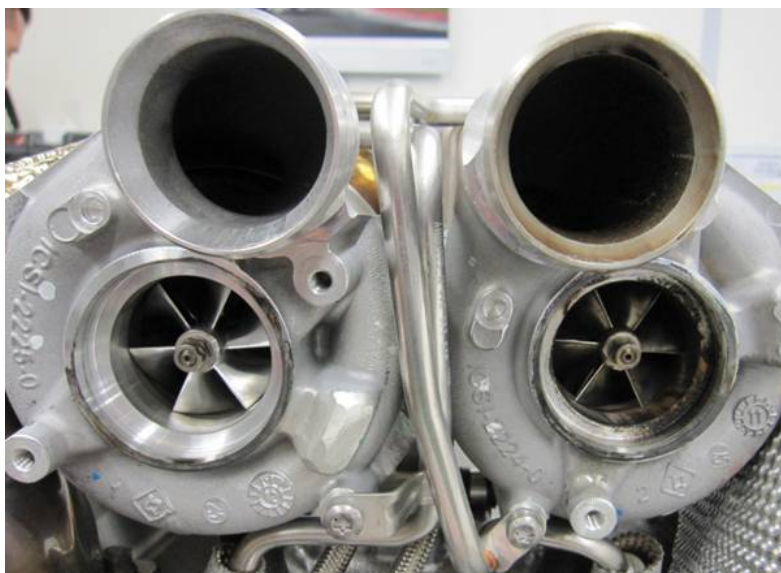
On 4.0I bi-turbo FSI engines, the pipe on the impeller side of the bank 2 turbocharger looks discolored when compared to the pipe on the bank 1 turbocharger.

The crankcase breather is only connected to the bank 2 turbocharger inlet. Blow-by gases from the crankcase breather discolor the pipe (Figure 1). This is a normal condition.

Figure 1. The pipe on the impeller side of the bank 2 turbocharger is discolored due to blow-by gases from the crankcase breather.

1. If necessary, explain to the customer that this is a normal condition.
2. Do not replace any parts due to this condition.
