Technical Service Bulletin

66 Servicing rear spoiler drive unit

66 16 56 2038477/2 August 2, 2016. Supersedes Technical Service Bulletin Group 66 number 14-41 dated October 6, 2014 for reasons listed below.

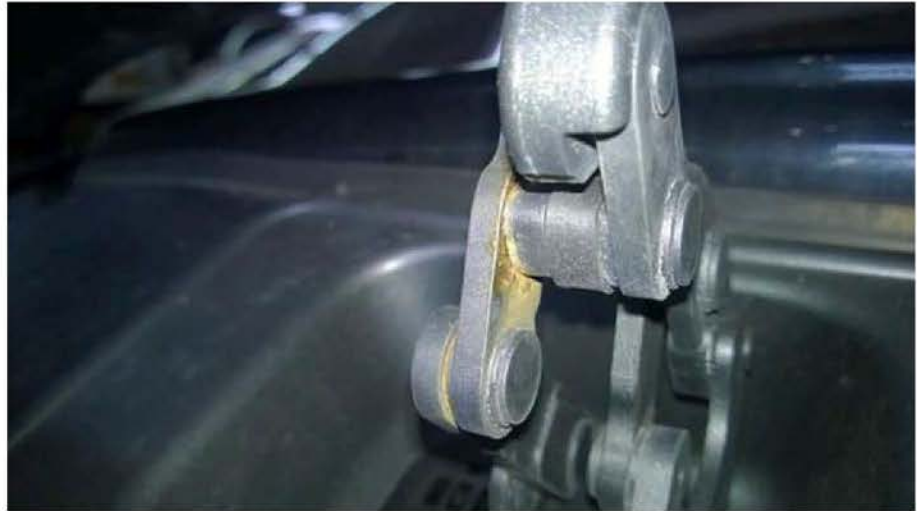
The rear spoiler operation can be restricted due to corrosion in the spoiler drive unit. As a result, the rear spoiler becomes stiff and does not reach its end points. This may cause a rear spoiler error light to be illuminated.

1. Check for corrosion on the spoiler drive unit hinge (Figure 1).

Figure 1. Corrosion on the spoiler drive unit hinge.

2. If corrosion in the drive unit hinge is found to be the cause of the function restriction, the hinges can be lubricated using special lubricant G 052172A1 (Figure 2).

Move the spoiler mechanism outward to expose the hinges and apply the special lubricant. Run the spoiler in and out several times to distribute the lubricant thoroughly into all of the hinge components.

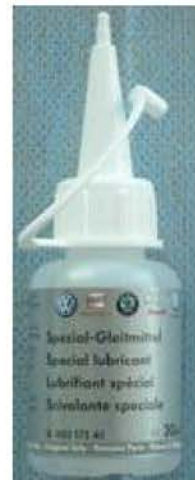
Figure 2. Special lubricant G 052172A1
