Technical Service Bulletin

91 MMI connect smartphone app warning messages do not refresh information or remote lock and unlock fails

91 16 66 2044853/1 August 12, 2016.

Model(s)	Year	VIN Range	Vehicle-Specific Equipment
A4	2017	All	Audi connect
Q7	2017	All	Audi connect

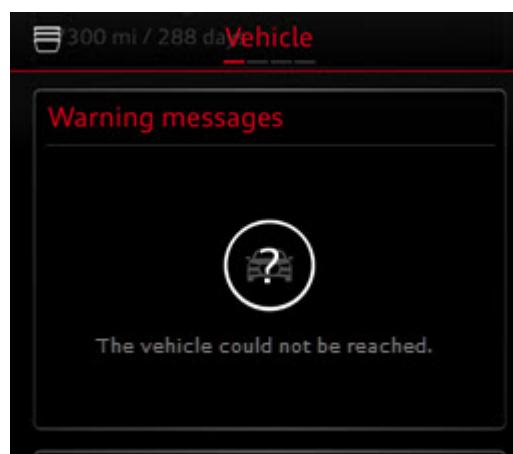
- The function "Warning messages" does not provide new data when the user manually attempts to refresh the data. An error message stating "The vehicle cannot be reached" can be seen in the app and the myAudi web site (Figure 1).
- The vehicle cannot be locked or unlocked with the app, and an error message stating "A technical error occurred" is displayed (Figure 2).

Figure 1. Warning messages cannot be refreshed.

- Replace the connected data bus diagnostic interface, J533 (address word 19).
- Using Guided Functions, select "Replace control unit".
- If the new replacement part does not have software version 4079 or higher, the control unit must be updated using the SVM update instructions below.

- Update the connected data bus diagnostic interface, J533 (address word 19) using the SVM update instructions below.

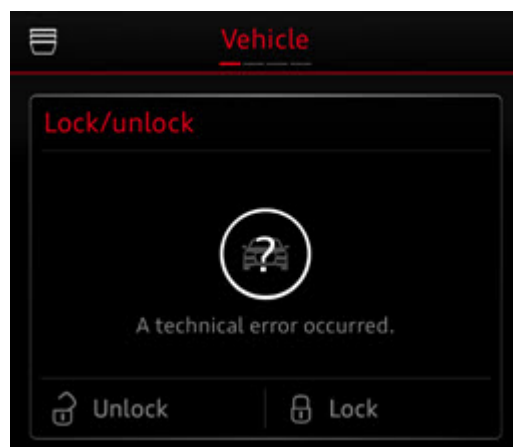
Figure 2. Lock/unlock error.

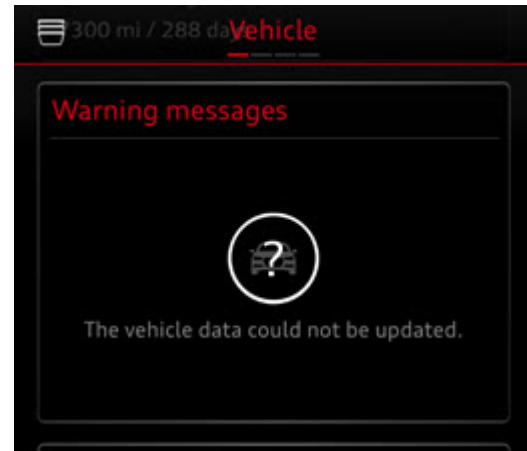
Tip: Not all errors in the MMI connect app indicate a problem. For example, the message “The vehicle data could not be updated” is displayed when the engine is on or when the vehicle is being driven, as data is not refreshed under these conditions (Figure 3).

Figure 3. Normal condition warning message.
