Technical Service Bulletin

91 MMI 3G+ MMI inop; blank screen at startup; various technical issues (K0942 ZUG update; supersedes K0814 update)

91 16 67 2030465/10 August 18, 2016. Supersedes Technical Service Bulletin Group 91 number 16-49 dated June 23, 2016 for reasons listed below.

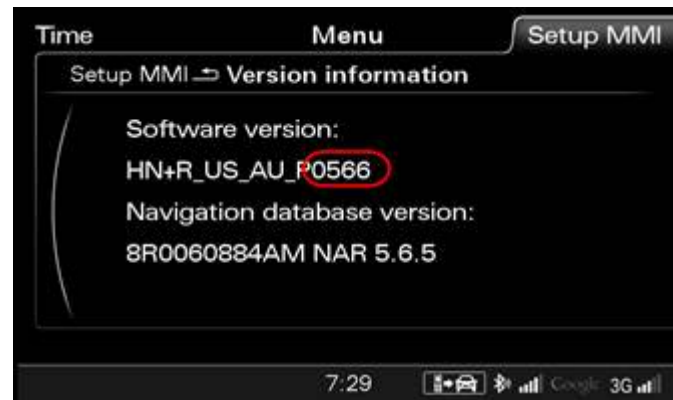
Tip: The MMI software version can be found under *Menu >> Setup MMI >> Version Information*. The software version will show the 4-digit software version number with a "P" or "K" prefix ("P" for Production and "K" for Service") (Figure 1).

Figure 1. Example showing MMI software version (0566).

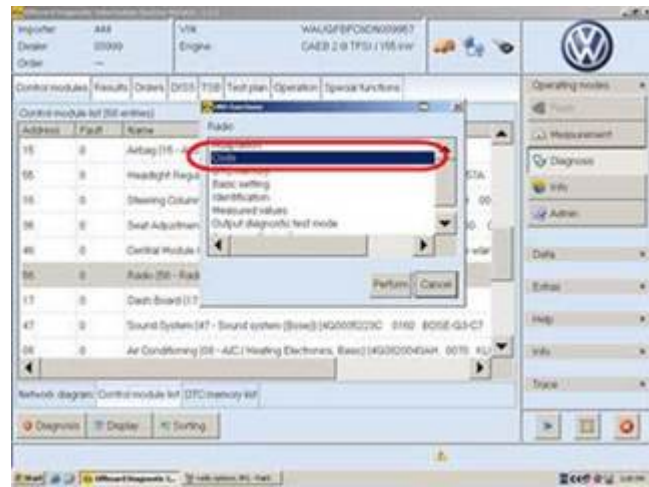
Figure 3. Code radio option.

3. Select *Code* (Figure 3).

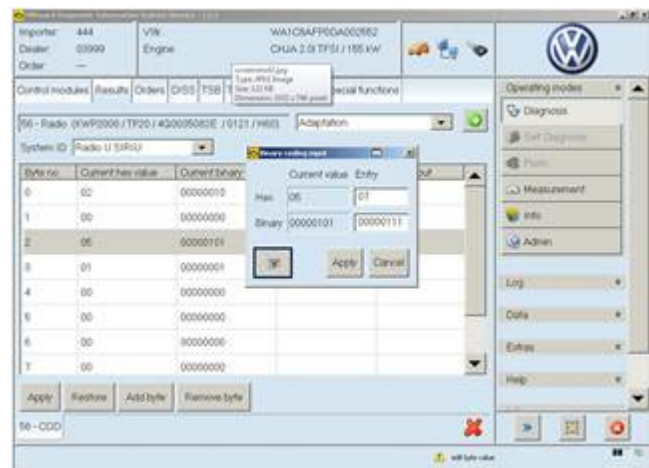
Figure 4. Changed radio coding.

4. Verify the coding in byte 2 is HEX 07.

- If it is not HEX 07, change the coding to HEX 07. Apply changes (Figure 4).

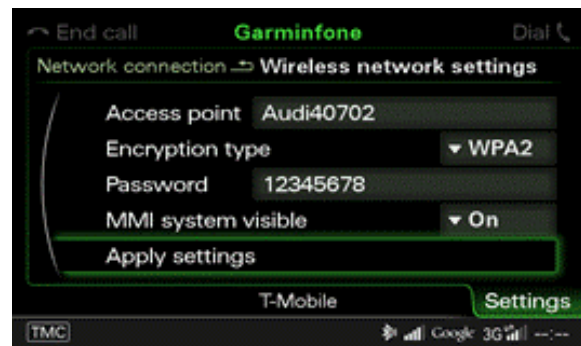
Figure 5. Wireless network settings.

6. As part of the update, wireless settings and paired devices will be deleted. All devices will need to be re-paired after the update, and all wireless settings restored to the customer's settings. To access the Wireless network settings on the MMI (Figure 5), press *TEL >> Settings >> Wireless network connection >> Wireless network settings*. Record all settings so they can be re-entered at the end of the update.

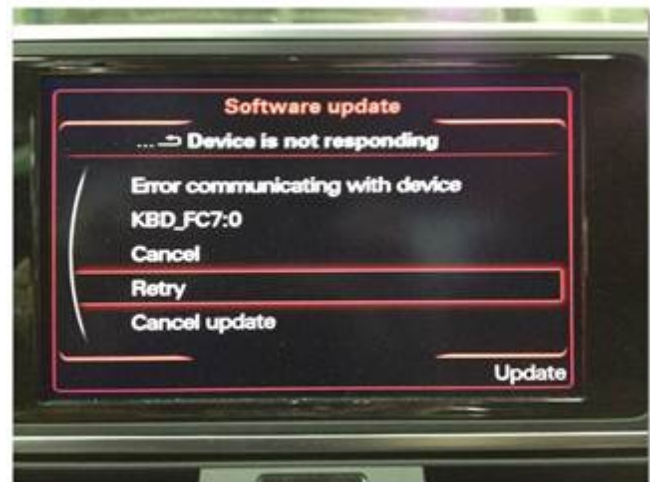
Figure 6. A device requiring a ‘Cancel’ selection.

Some earlier model year 2012 vehicles, or vehicles equipped with Bose® sound systems may experience certain modules that will not update properly during Step 16 of TSB 2028141. If this should occur, either choose ‘Cancel’ (Figure 6), or ‘Skip device’ (Figure 7), depending on the type of error. Do *not* choose ‘Cancel update’, as this may cause the software update to fail entirely. After the update is finished and the summary page is shown, select ‘Retry’ at the bottom of the list if it is available to attempt to update the modules again. If ‘Retry’ is greyed out, then the software update was successful. Select ‘Continue’ to proceed. In some cases ‘Retry’ may have to be repeated two or three times to get all modules to update successfully.

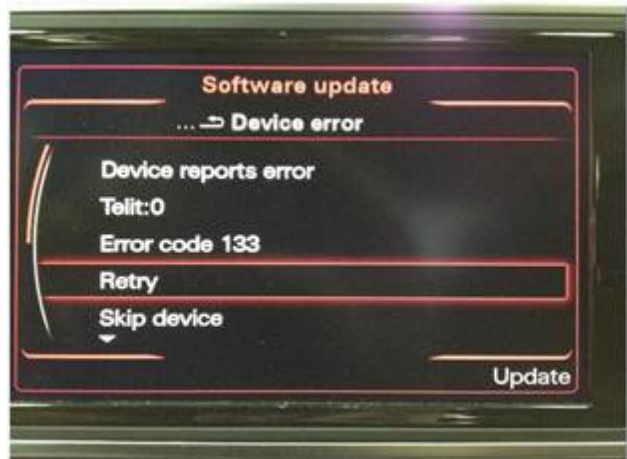
Figure 7. A device requiring a 'Skip device' selection.

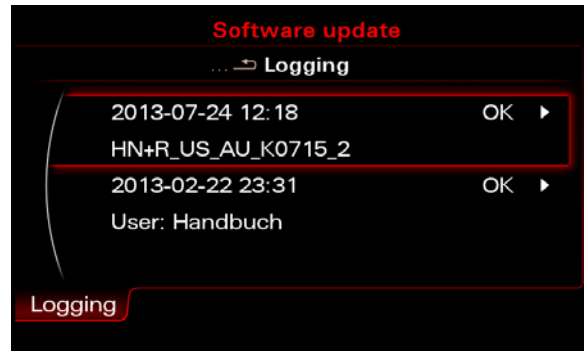
Figure 8. Software update log showing a successful software installation.

- Verify that the software update has been completed successfully by accessing the logging page (Figure 8). To access this screen, proceed to step 8 in TSB 2028141 and press the lower left softkey. A successful update will show the date the update was performed and the software that was installed (HN+R_US_AU_K0715_X), with 'OK' listed on the right (example 0715 installation). The 'X' may be one of several different numbers. If K0715_X does not have any rows with 'OK', the update must be retried until it is successful. For the latest P0942 update, this line would show K0942_X.

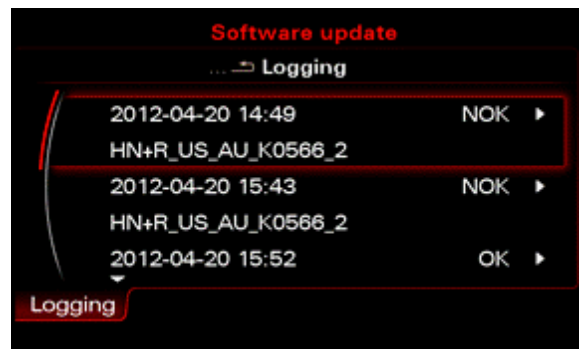
Figure 9. Software update log showing 2 failed attempts before a successful installation.

Tip: If the update must be performed two or more times due to modules not updating correctly, a screenshot of the software update log is required (Figure 9). This should be kept on-hand for warranty auditing purposes. To take a screenshot, insert an SD Card into slot 1. For A6/A7/A8/Q7, press and hold the left and right arrow keys at the same time. For A4/A5/Q5, press and hold the bottom two softkeys at the same time. All 4 softkeys will flash when the screenshot is taken. A screenshot should be taken of each page in the logging display.
