<b>Subject:</b> <b>UNABLE TO LOWER REAR SEATBACK WITH REMOTE HANDLE / SEATS HARD TO LOCK</b>	<b>Bulletin No:</b> 09-031/16
	<b>Last Issued:</b> 05/10/2016

2013-2016 CX-5 vehicles equipped with a 40:20:40 split type rear seat

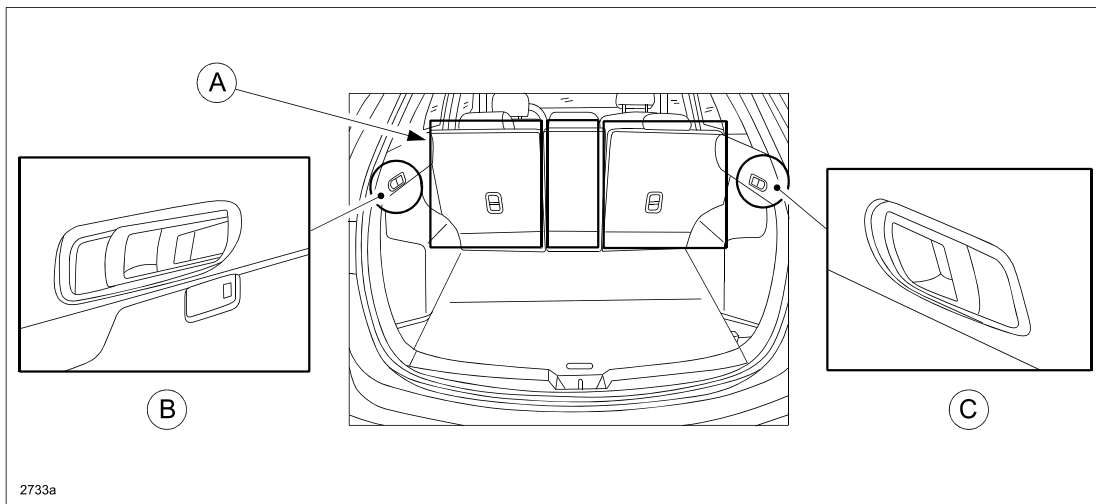
Some vehicles equipped with a 40:20:40 split type rear seat may be unable to lower the rear seatback (A) when pulling the left (B) and/or right (C) remote handles. Also, the seatbacks may not fully latch (lock) when placed in the upright position.

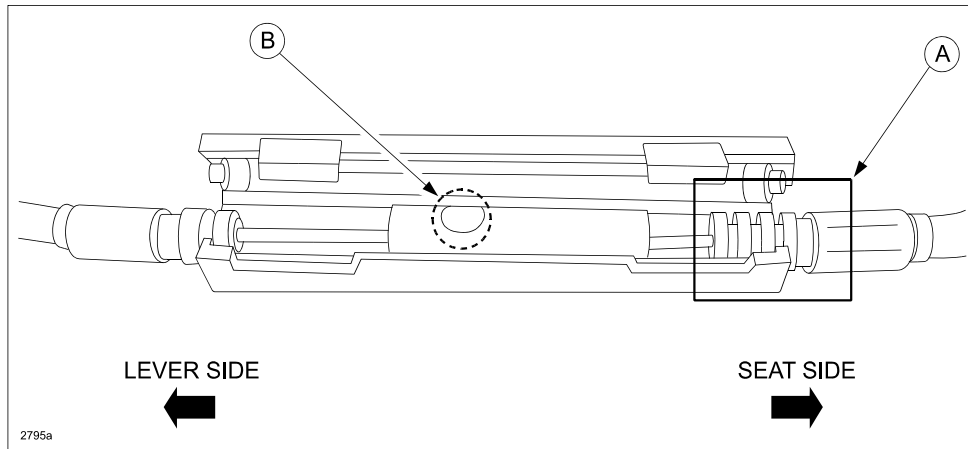
This concern may be caused by either of the following:

- Insufficient remote cable tension due to incorrect adjustment position (A) of the remote cable.
- The cable ball (B) gets seized on sharp edges inside the cylinder.
