Subject: WATER ENTRY INTO TRUNK LID LIGHT DURING HIGH PRESSURE CAR WASH	Bulletin No: 09-033/16
	Last Issued: 05/13/2016

2014-2015 Mazda6 vehicles with VINs lower than JM1 GJ ***** 170534 (produced before January 29, 2014)

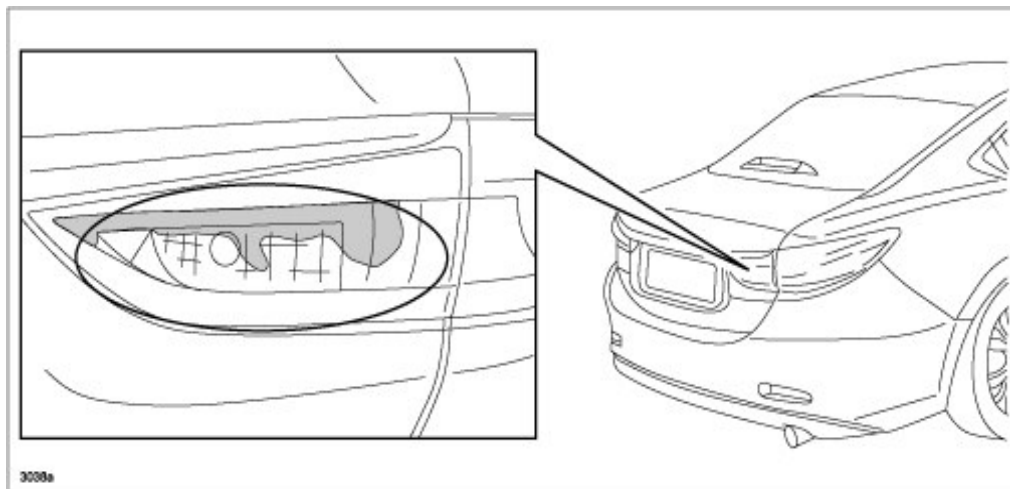
Some vehicles may exhibit a condition that water enters into the trunk lid light while washing the vehicle with high pressure. Water may enter through the trunk lid light gasket and the body panel.

Customers having this concern should have their vehicle repaired using the following repair procedure.
