Subject: WHITE DUST UNDER FRONT SEATS AND / OR FRONT SEAT CUSHION SIDE SUPPORT COLLAPSED	Bulletin No: 09-034/16
	Last Issued: 05/13/2016

2016 CX-3 vehicles with VINs lower than JM1 DK ***** 138624 (produced before April 1, 2016)

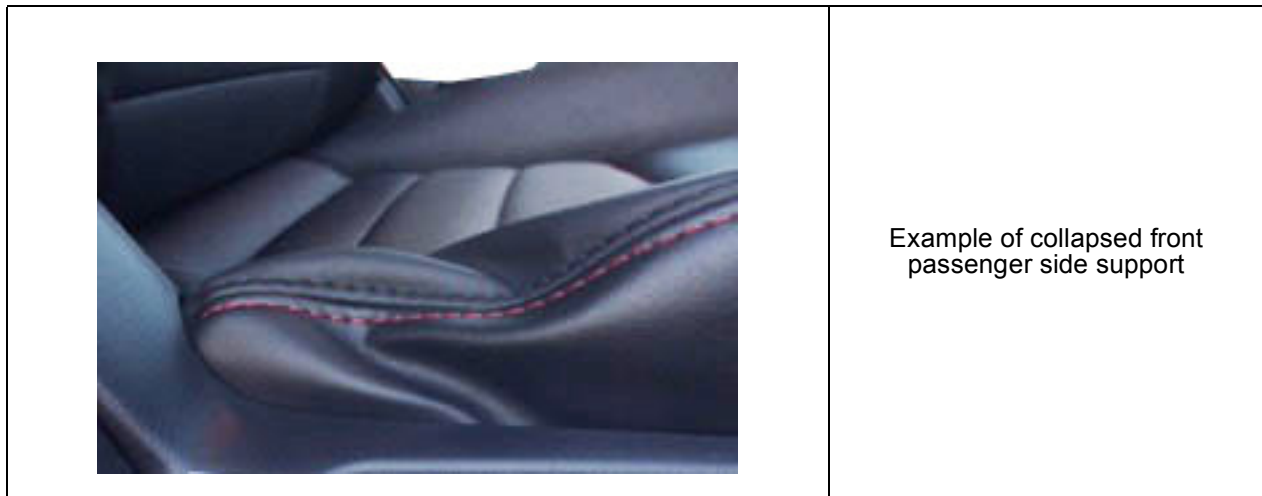
Some customers may find white dust under front seats and/or partially collapsed side support of the seat cushion. The seat cushion pad may fall into the inside of the frame temporarily and may be shaved by the edge of the frame when it returns to the original position.

Customers having this concern should have their vehicle repaired using the following repair procedure.
