| <b>Subject:</b><br><br>AIR FROM VENTS NOT COLD WITH AIR CONDITIONER ON | <b>Bulletin No:</b> 07-002/16 |
| | <b>Last Issued:</b> 05/17/2016 |

2014 Mazda3 vehicles (Mexico built) with VINs lower than 3MZBM\*\*\*\*\*174272 (produced before December 1, 2014)

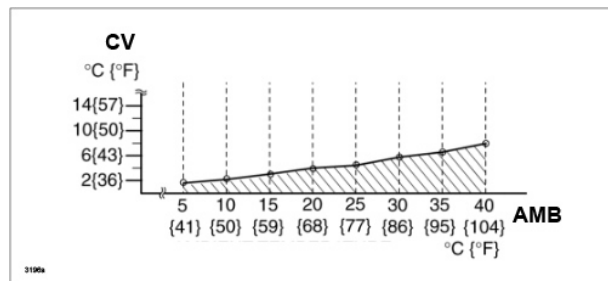
1. Verify customer concern by measuring the temperature of the air from the center vents (CV). Check to see if it is within specification of the ambient temperature (AMB) in the following chart.

- If the temperature is within specification, there is no problem with the A/C system.
- If the temperature is NOT within specification, go to next step.

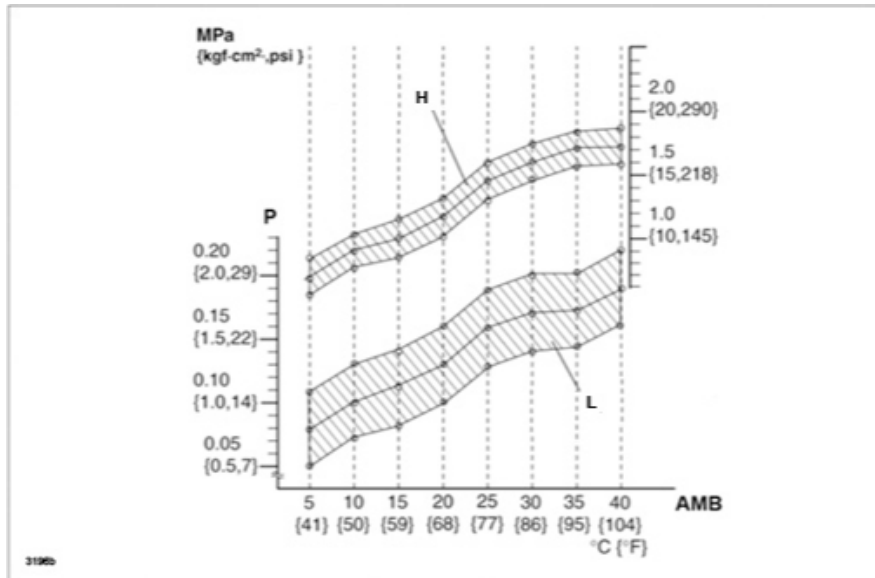
2. Perform "REFRIGERANT PRESSURE CHECK" according to the Workshop Manual . Check to see if the pressure reading of the the manifold gauge (P) is within specification of the ambient temperature (AMB) in the following chart.

- If the refrigerant high-pressure (H) is extremely high and the refrigerant low-pressure (L) is extremely low, go to next step.
  - If the refrigerant pressure is within specification, diagnose the cause using to the Workshop Manual.
  - If the refrigerant pressure is low, refill the system and inspect for the cause of the refrigerant leak.
3. Replace the whole A/C system line with new parts according to the procedures in the following sections of the Workshop Manual.
    - A/C UNIT REMOVAL/INSTALLATION
    - A/C COMPRESSOR REMOVAL/INSTALLATION
    - CONDENSER REMOVAL/INSTALLATION
    - REFRIGERANT LINE REMOVAL/INSTALLATION
  4. Verify repair.
