Subject: PASSENGER-SIDE SEAT WARMER IS SLOW TO WARM UP - (CLOTH SEAT ONLY)	Bulletin No: 09-035/16
	Last Issued: 05/19/2016

2016 CX-5 vehicles (equipped with cloth seats only) with VINs between JM3KE*****600001 - 772816 (produced from Nov. 3, 2014 to Feb. 1, 2016)

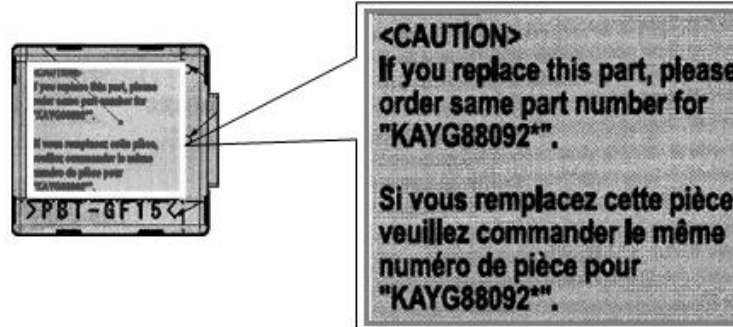
NOTE: The following caution label is attached to the top of the modified Coupler, Box (KAYG-88-092) service part. The label indicates that the same modified service part should be used again, in the event of a future parts replacement.
