# Technical Service Bulletin

## 20 Fuel cannot be added to vehicle or fueling vehicle is difficult

20 16 68 2044039/1 April 28, 2016.

Model(s)	Year	VIN Range	Vehicle-Specific Equipment
Q7	2017	All	Not Applicable

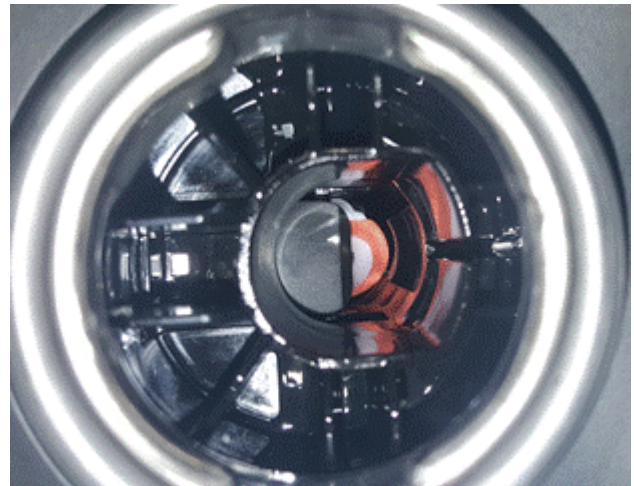
Vehicle does not accept fuel, is slow to refuel, or it is difficult to insert the fuel pump nozzle.

There is a broken flap inside of the filler neck (Figure 1).

*Figure 1. Broken flap inside of filler neck.*

Replace complete fuel tank according to the instructions in ELSA at: *Repair Manual*>>*Power Unit*>>*Fuel Supply*>>*Fuel tank*>>*Removing and installing fuel tank*.
