Technical Service Bulletin

24 DTC P19A200 after ECM replacement or software update

24 16 52 2043894/1 April 14, 2016.

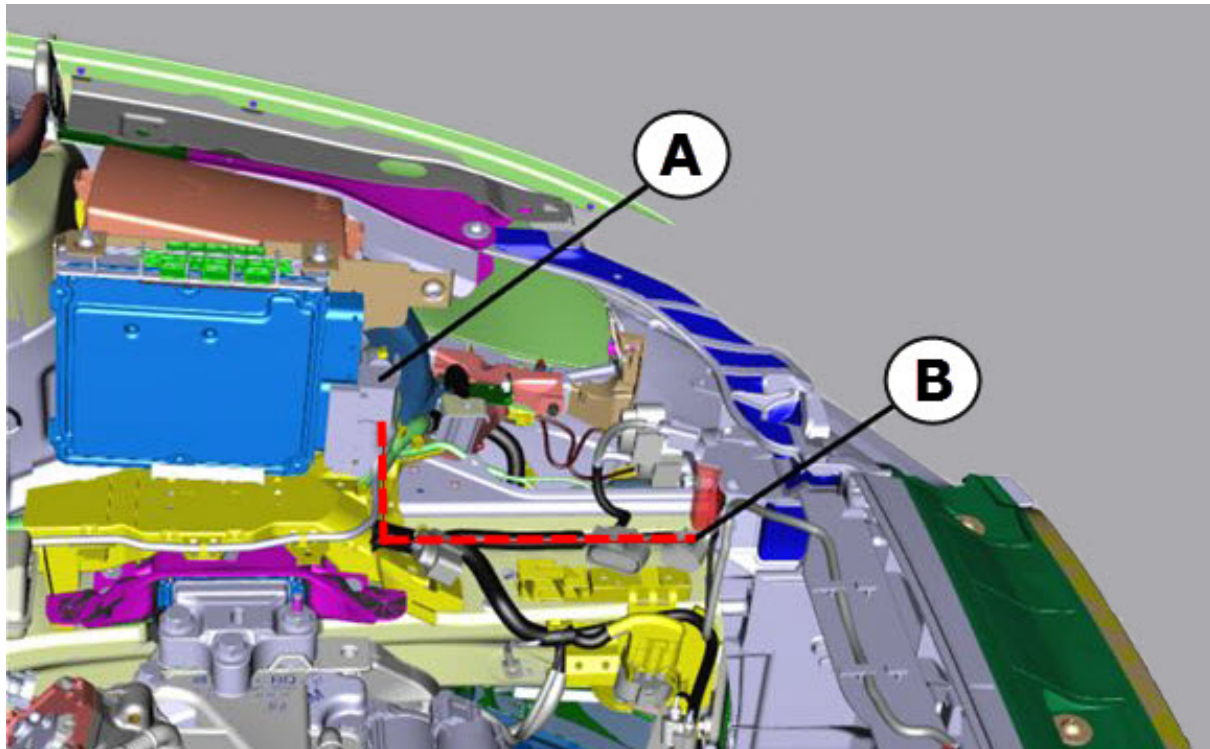
From software version 0004, a diagnosis of the control circuit for the transmission coolant valve is active, but on some vehicles the control circuit (wire) for the valve was not installed by the factory. The missing wire creates a permanent open circuit for the diagnosis line of the transmission coolant valve. There is no restricted function for the customer and the vehicle operates normally.

Figure 1. Pin 39 on connector T91 (A), pin 1 on connector T14 (B), start and end route for the missing wire (dotted red line).

- Route a new cable from pin 39 on connector T91 to pin 1 of connector T14 (grey connector, part number 5Q0 973 737) on the vehicle end. See Elsa repair manual for location. Route the missing wire along the wiring harness (Figure 1).
- Proceed to *Wiring Harness Repair Instructions, Part 1* below.

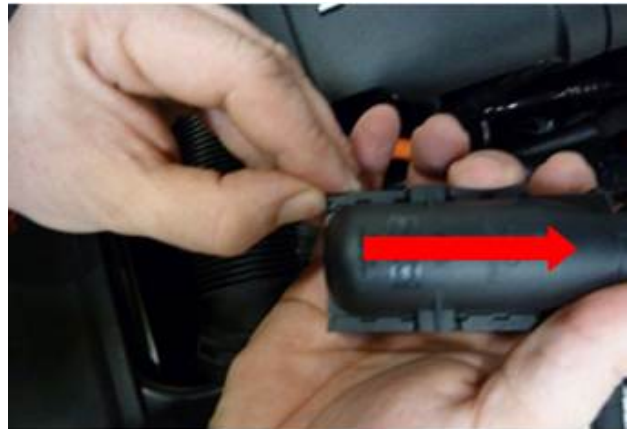
Figure 3. Detaching the protective cap.

1. Push the protective cap on the unlocking mechanism out of the connector housing. Next, push the protective cap toward the connector unlocking mechanism in the direction shown (Figure 3) and detach the protective cap from the connector.

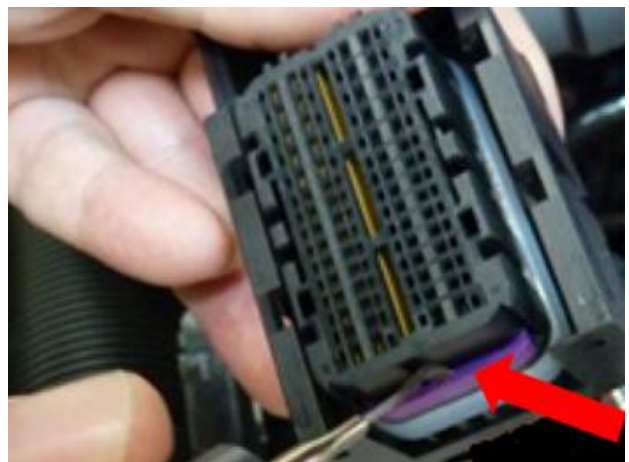
Figure 4. Removing secondary lock.

2. Use VAS 1978/17 or a small screwdriver to remove the secondary lock from the housing (Figure 4).

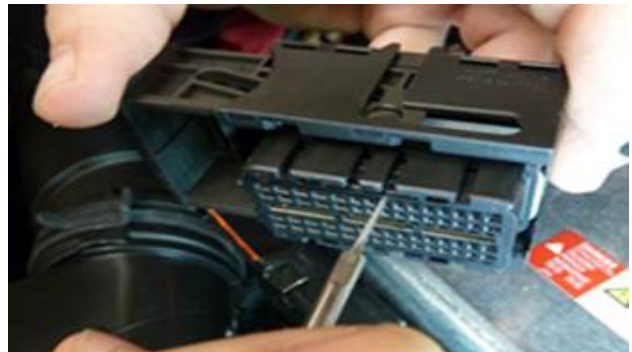
Figure 5. Removing the seal pin.

3. Use VAS 1978/35-2 to remove the seal pin from pin 39 (Figure 5).
