Technical Service Bulletin

35 Gearbox warning light on (DTCs P179E00, P179F00, P0700, P060A)

35 16 22 2032211/4 April 18, 2016. Supersedes Technical Service Bulletin Group 35 number 16-19 dated January 11, 2016 for reasons listed below.

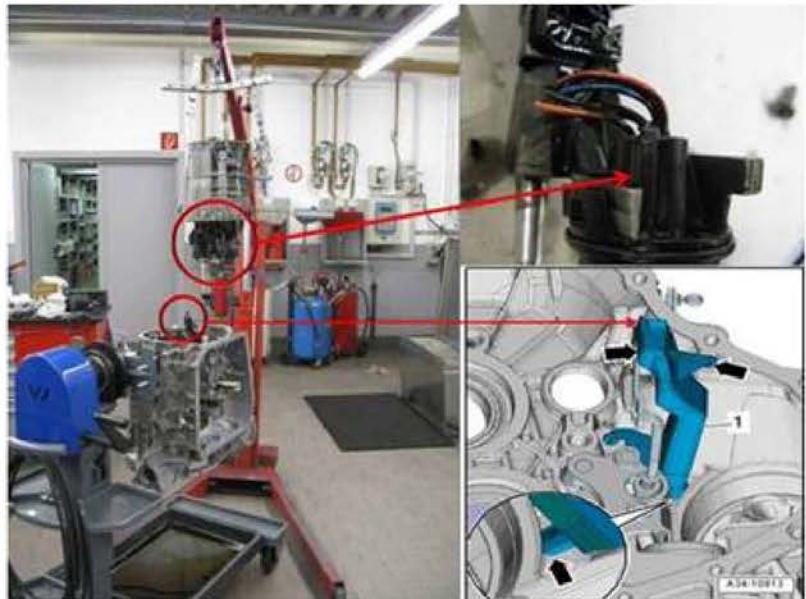
Tip: Use caution when lifting or lowering intermediate housing to avoid damage to components (Figure 2).

Figure 2. Caution points: drip tray and sensor module connector.
