# Technical Service Bulletin

## 37 Selector lever malfunction (DTC P17EE00 - release button implausible signal)

37 16 62 2043817/1 April 5, 2016.

Model(s)	Year	VIN Range	Vehicle-Specific Equipment
Q7	2017	000001 - 006930	Not Applicable

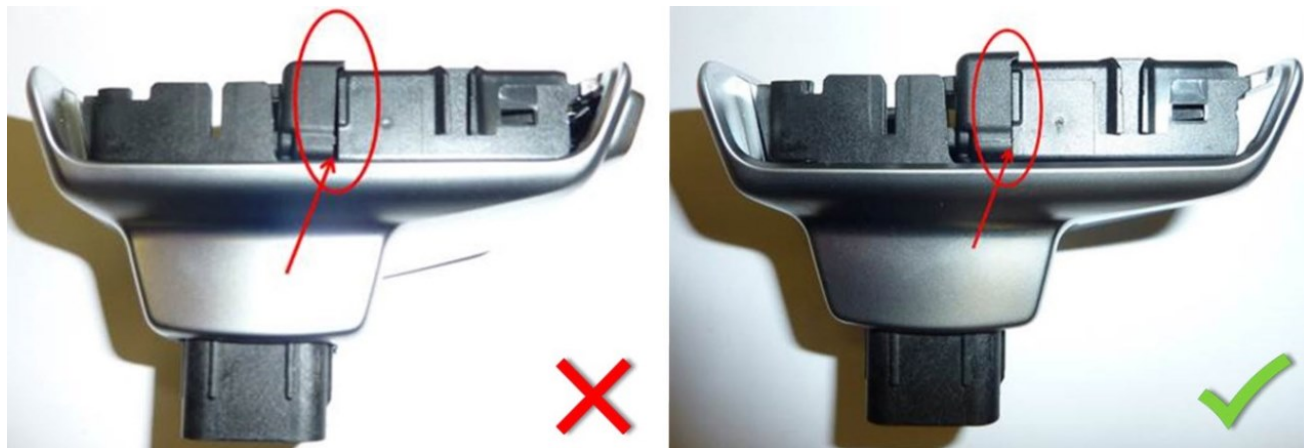
Installation of switch cover is incorrect.

**Figure 1.** Incorrectly-installed (left) and correctly-installed (right) cover.

1. Remove the upper selector lever handle (the leather-covered section) according to the Elsa repair manual.
2. Check the attachment of the cover of the release button sensors in the front of the shifter to determine if it is correctly installed (Figure 1).

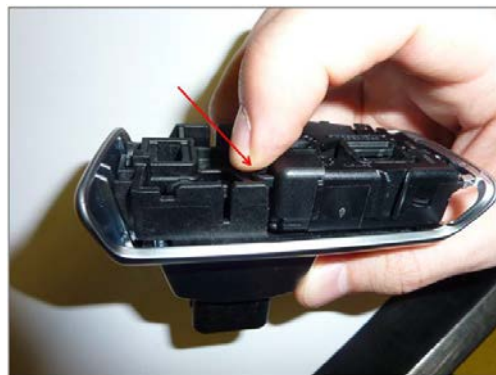
**Figure 2.** Apply force to fully install the cover.

- Push the cover into the correct position by applying force, as shown (Figure 2). A clicking noise confirms the attachment in the lower retaining lug.
- After the attachment is made, confirm that the gap between the two parts matches the image (Figure 2), and that the release button clicks when operated.
- Delete the fault, then reinstall the upper selector lever handle.

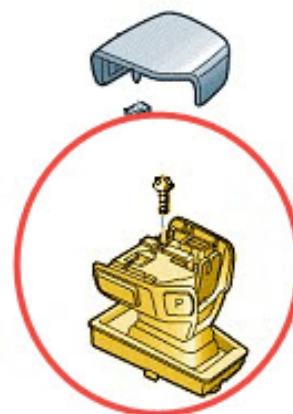
**Figure 3.** Lower shift lever handle (circled).

- Replace the lower shift lever handle (Figure 3). (Note that the part must be ordered based on vehicle VIN due to available color options.)
