# Technical Service Bulletin

## 68 Parking aid malfunctions

68 16 16 2043850/1 April 28, 2016.

Model(s)	Year	VIN Range	Vehicle-Specific Equipment
Q7	2017	All	Not Applicable

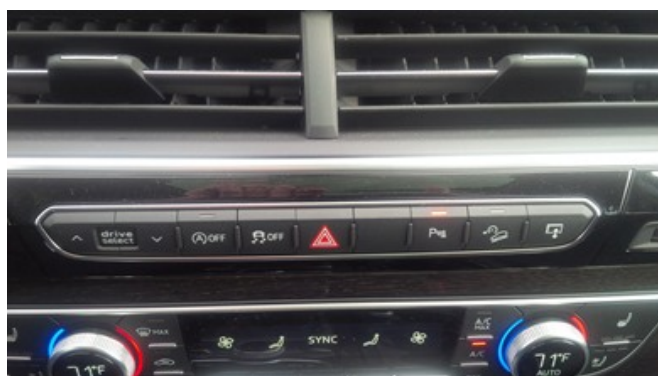
- The LED on the Park Assist button is flashing to indicate an error with the system, and an error message is displayed on the DIS (Figure 1 and Figure 2).
- Other symptoms may include loss of courtesy lamp operation or loss of glovebox illumination.
- Fuse ST5 SB15 may be blown (Figure 3).
- One or more of the following DTCs may be stored in the vehicle electrical system control module, J519 (address word 09):
  - **DTC U141200** (Terminal 30-2 Open circuit)
  - **DTC B14BB14** (Rear parking aid warning buzzer Open)
  - **DTC B14BA14** (Front parking aid warning buzzer Open)
  - **DTC B131411** (Supply voltage for interior lighting Short circuit to ground)
  - **DTC B14BB12** (Rear parking aid warning buzzer Short circuit to B+)
  - **DTC B14BA12** (Front parking aid warning buzzer Short circuit to B+)

Figure 1. LED on Park Assist button E266.

Remove both sun visors and inspect the wiring in the visor mounting as well as the wiring in the roof leading to the sunvisors.

- If the wiring in the visor is damaged, replace the sunvisor (Figure 4).
- If the wiring in the roof harness is damaged, it can be repaired using the VAS 1978B (Figure 5).
- If fuse ST5 SB15 if it is found to be blown, replace it.

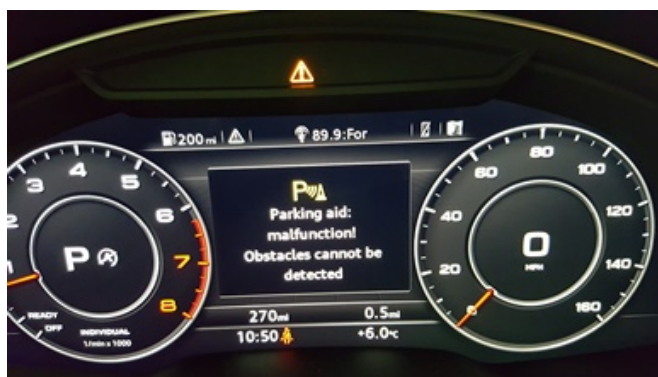
Figure 2. Error on the DIS that appears for the customer.

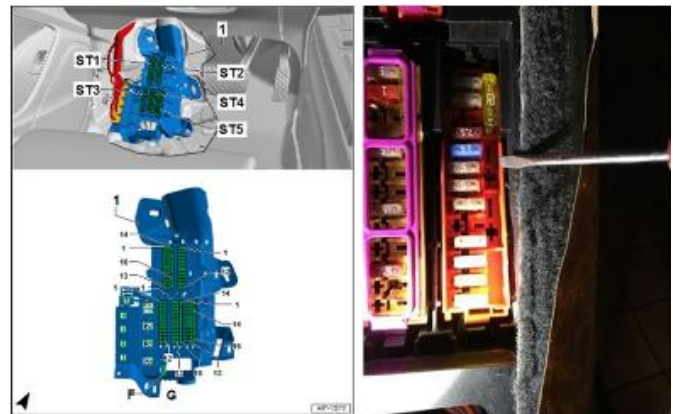
Figure 3. Fuse location.

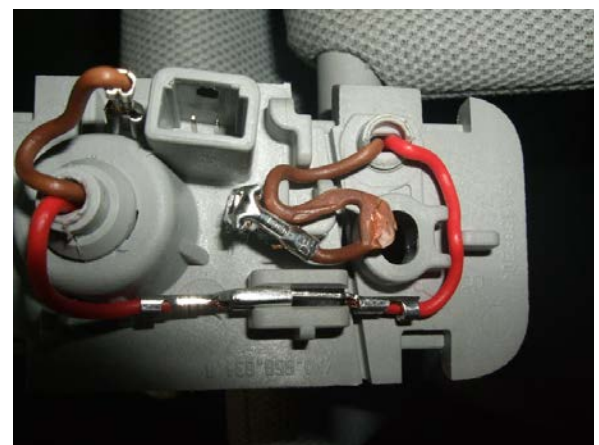
The sunvisor wiring or the wiring in the roof leading to one or both sunvisors is damaged (shorted to B+, shorted to ground or open) due to the wiring routing or damage from the sunvisor mounting screw.

Figure 4. Sunvisor wiring damage typically found after visor removal and inspection.

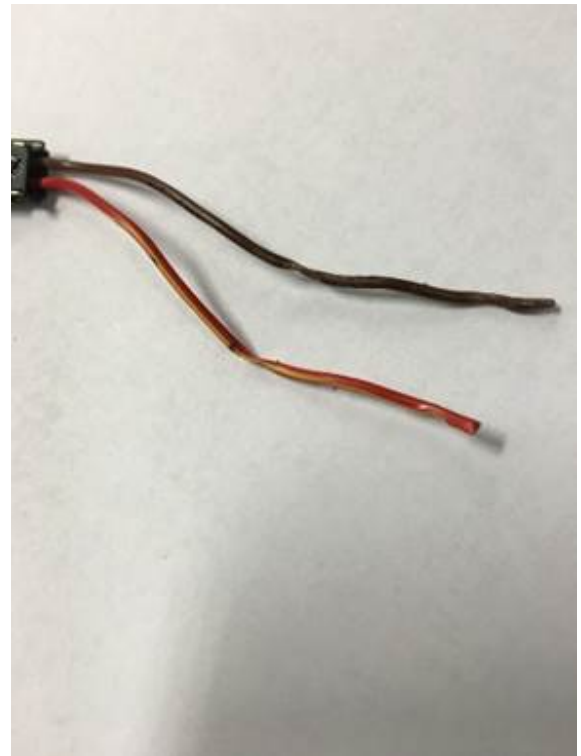
**Figure 5.** Damage typically found on roof harness.
