Technical Service Bulletin

91 Antenna technical problem message (DTC 02617)

91 16 36 2041940/2 April 12, 2016. Supersedes Technical Service Bulletin Group 91 number 15-13 dated September 23, 2015 for reasons listed below.

Model(s)	Year	VIN Range	Vehicle-Specific Equipment
A4, A5	2016	All	Not Applicable

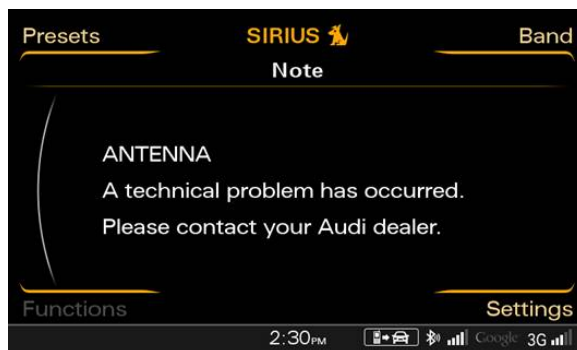
- The following message is displayed in the driver information panel when in the SiriusXM band:
 - “ANTENNA - A technical problem has occurred. Please contact your Audi dealer.” (Figure 1).
- Audio from the satellite radio is present.
- **DTC 02617** (Satellite antenna) is stored in the radio (address word 56) with fault code 11 (Open circuit).

Figure 1. ANTENNA message.

- Update the software using the *SVM Update Instructions* below. The new software will update open circuit detection parameters in the radio control module (address word 56).

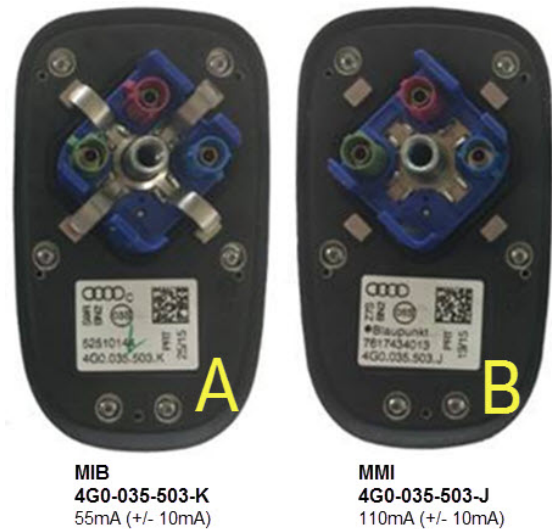
Visually, the MMI and MIB antennas are the same (Figure 2), but each antenna draws a different amount of current. For this reason, if an MIB antenna has been installed on a vehicle with an MMI radio, it causes an open circuit DTC. The open circuit DTC will be set on an MMI radio if the current draw from the antenna falls below 60mA .

- A MIB antenna draws 55mA (+/- 10mA) 4G0-035-503-K
- A MMI antenna draws 110mA (+/- 10mA) 4G0-035-503-J

Figure 2. MIB antenna with K suffix part number 4G0-035-503-K (A), and MMI antenna with J suffix part number 4G0-035-503-J.

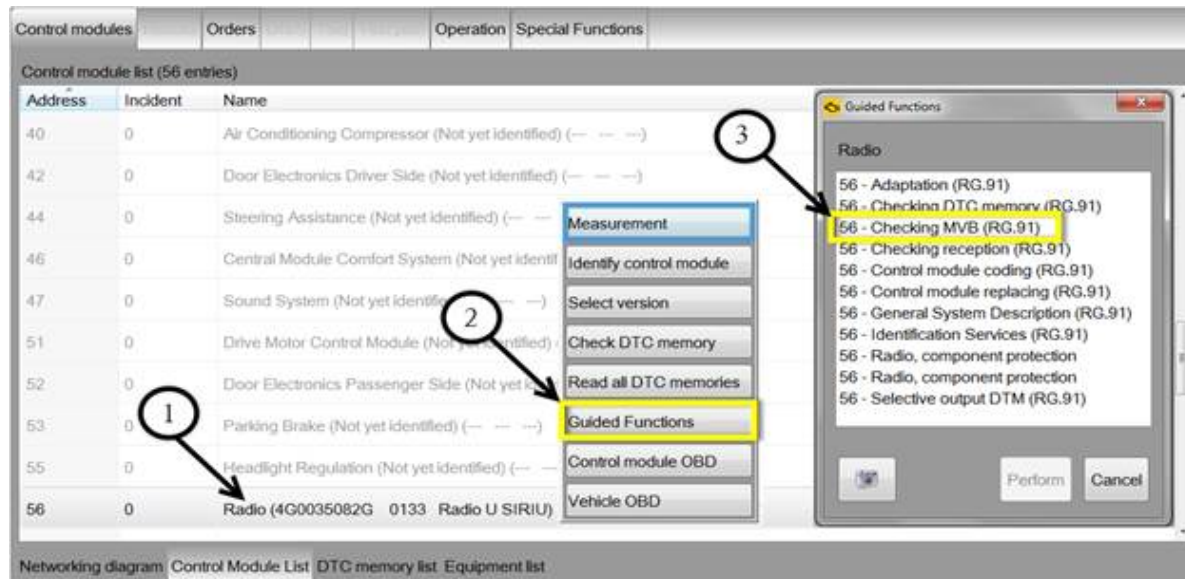
Figure 3. Access radio measured value blocks by right-clicking the radio module (1), then selecting Guided Functions (2), then selecting Checking MVB (RG.91) and clicking Perform. (Shown for MMI 3G+.)

1. Check the current consumption of the shark fin antenna through ODIS GFF.
2. In ODIS GFF, access the measured value blocks of the radio (address word 56) (Figure 3).

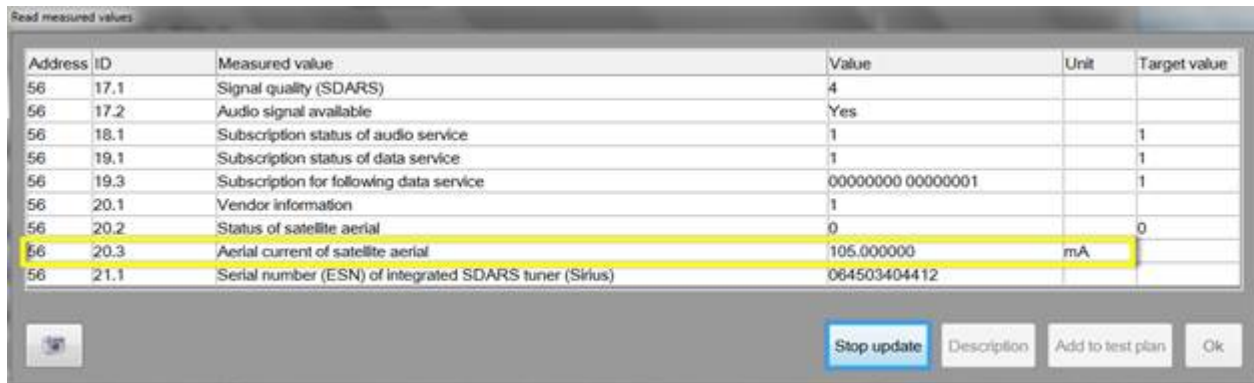
4. Check the current consumption of the satellite radio antenna (MVB 20.3 for MMI 3G+; MVB 9.3 for CAN radio) (Figure 5):
 - If the current consumption shown on an MMI system is between 40mA – 100mA, proceed to step 5.
 - If the current consumption of the antenna is above 100mA, this TSB does not apply. Continue to diagnose the concern outside of this TSB.

Figure 5. Check the current consumption of the satellite radio antenna. (Shown for MMI 3G+.)
