LINCOLN:

2017 Continental

TSB 16-0159 (Continued)

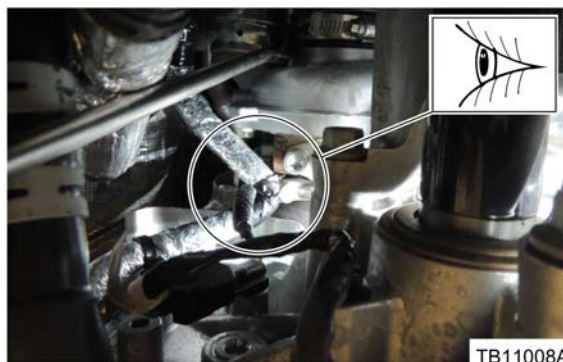
Figure 1 - Article 16-0159

3. Raise the vehicle and remove the underbody shield if equipped. Refer to Workshop Manual (WSM), Section 303-01.
4. Visually inspect the engine wiring harness to the power transfer unit (PTU) cooling pump, near connector C1586, for contact and wire chaffing with the electronic power assist steering (EPAS) PTU heat shield. Was a wiring issue found? (Figure 1)

5. Disconnect the battery. Refer to WSM, Section 414-01.
6. Disconnect the PTU temperature sensor.
7. Disconnect the harness push pin retainer on the EPAS heat shield and the two push pin retainers on the PTU.
8. Disconnect the PTU coolant pump electrical connector and the PTU coolant pump harness retainers.
9. Position the wiring harness towards the rear of the vehicle to access the damaged wires.
10. Repair the wire concern. Refer to cell 5 in the Wiring Diagram (WD). The wiring harness should also be wrapped with Rotunda Technician Tool Program (RTTP) Coroplast wiring harness tape or equivalent.
11. Add a new wiring harness retention clip to the harness 20 mm (13/16") closer to the PTU from the original clip. This will move the harness away from the PTU to prevent chafing on the PTU housing. Remove and discard the original retention clip. (Figure 2)
