Technical Service Bulletin

91 Audi drive select, cruise control, navigation, Bluetooth, smartphone interface, or voice recognition is not available

91 16 37 2042506/2 April 14, 2016. Supersedes Technical Service Bulletin Group 91 number 15-25 dated November 17, 2015 for reasons listed below.

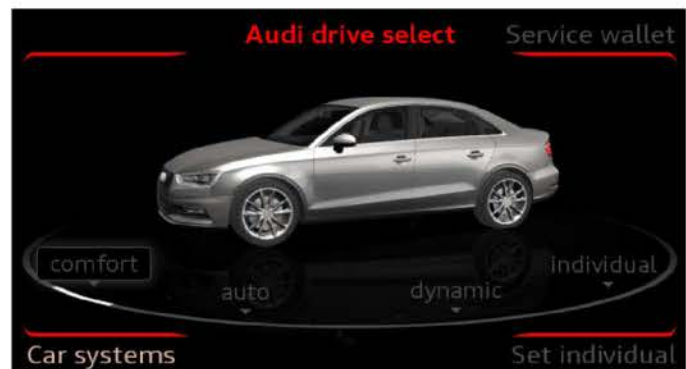
Figure 1. Audi drive select functions unavailable and greyed-out.

1. In ODIS, run the SVM Activations test plan at *FLASH >> START FLASH >> SVM Activations >> PERFORM TEST >> -2- Obtain existing activations from server for replacement control module?* (Figure 5).

2. When prompted, select “obtain existing activations.”
3. If the complaint persists, reset terminal 30 (for five minutes), then disconnect ODIS, roll the windows up, and lock the car to allow the vehicle systems to go to sleep. Allow the vehicle to sit for at least two minutes before turning on the ignition.

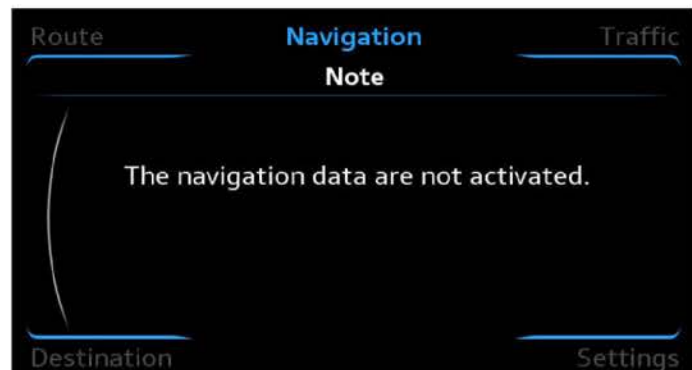
Figure 2. Navigation not activated message (Original MIB HMI)

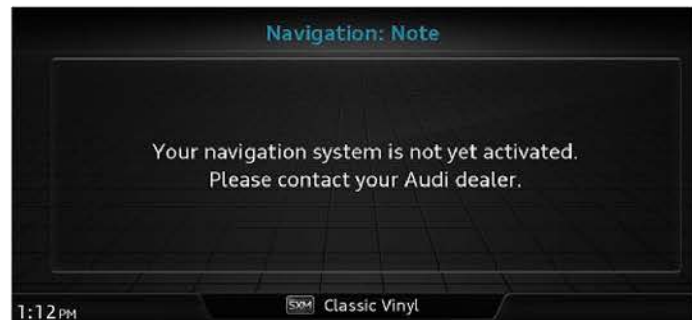
Figure 3. Navigation not activated message (New MIB2 HMI)

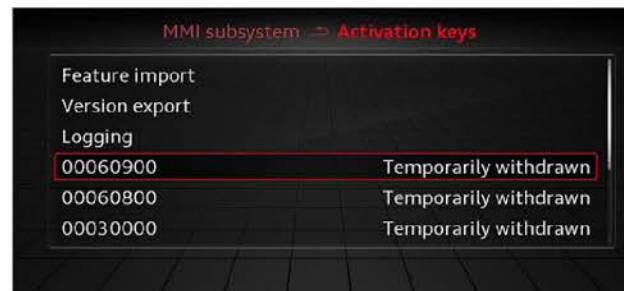
Temporarily withdrawn or Temp illegal = This indicates that the SVM activation test plan was not completed (Figure 4). This status is normal for all parts that have been swapped from a different vehicle. Perform the SVM Activations test plan as indicated below, under *Repair Procedure*.

Figure 4. Activation keys showing “Temporarily withdrawn”

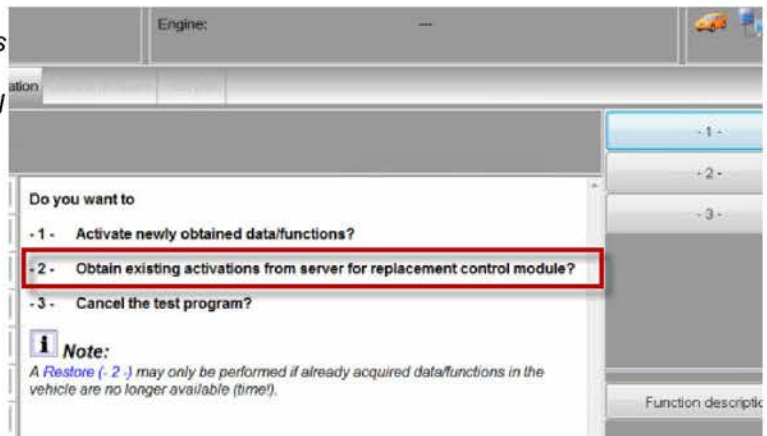
Figure 5. Obtain existing activations from server for replacement control module?
