Technical Service Bulletin

91 Mechanical drive for MMI screen: noises, reverses in lower end stop

91 16 38 2043835/1 April 14, 2016.

Model(s)	Year	VIN Range	Vehicle-Specific Equipment
Q7	2017	All	MMI High

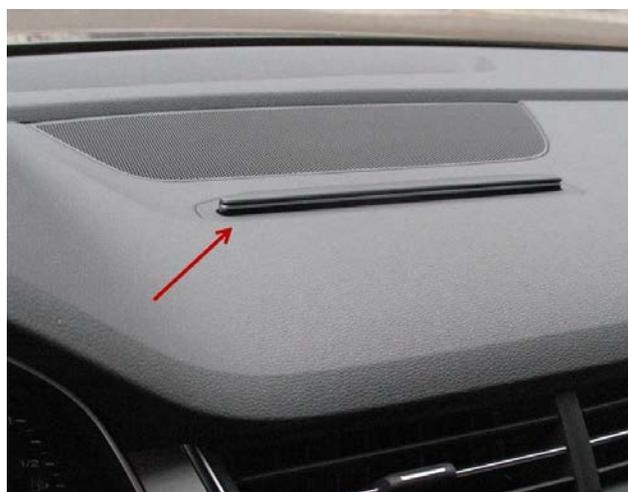
- The drive unit for the MMI screen makes noises as the screen moves into the lower area.
- The MMI screen may stop before it is completely retracted into the panel (Figure 1).

Figure 1. MMI screen stops before completely retracted into panel.

When the drive mechanism moves in, it reverses several times in the lower end stop, which causes the cracking noise. Additionally, the overload protection on the lower end stop can be activated because the drive mechanism moves too quickly.

New software in the screen drive control module, J674, addresses the condition. The speed of the MMI swivel mechanism was reduced on the multimedia system operating unit with software version 0165.

The software of the screen drive control module must be updated with an SD card (part number 4M0906961J), which should be ordered in advance.

1. Follow all instructions in the TSB 2011732: *00 Software Version Management (SVM), operating instructions*.
2. Update the screen drive control module, J674, using the SVM action code as listed in the table below if necessary.
