# Technical Service Bulletin

## 61 Water leak at front corners of convertible top

61 16 24 2024108/4 June 8, 2016. Supersedes Technical Service Bulletin Group 61 number 11-12 dated February 23, 2011 for reasons listed below.

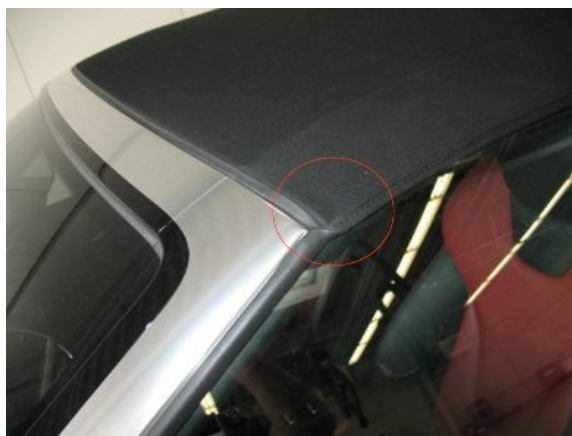
After heavy rain, water can migrate beyond the front convertible top header seal in the area where the convertible top header meets the windshield. The leak may not be immediately noticeable, but after a period of time following strong rainfall, the leaks can become evident in the front corners (Figure 1 and Figure 2).

**Figure 1.** Location where a leak may occur.

A section of butyl cord is installed in the roof frame seal (header) to close the path of water migration.

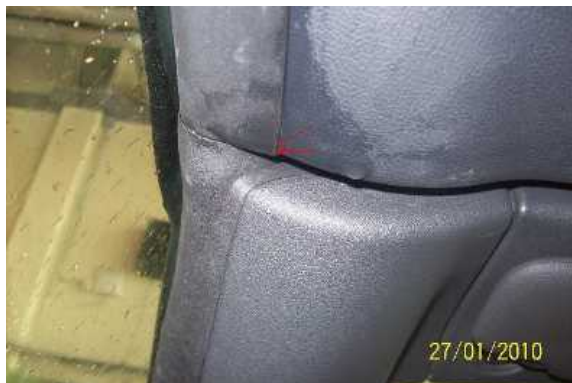
*Figure 2. Evidence of a leak.*
