# Technical Service Bulletin

## 70 Noises from headliner / sunroof area

70 16 51 2044417/1 June 3, 2016.

Model(s)	Year	VIN Range	Vehicle-Specific Equipment
Q7	2017	000001 - 005307	Not Applicable

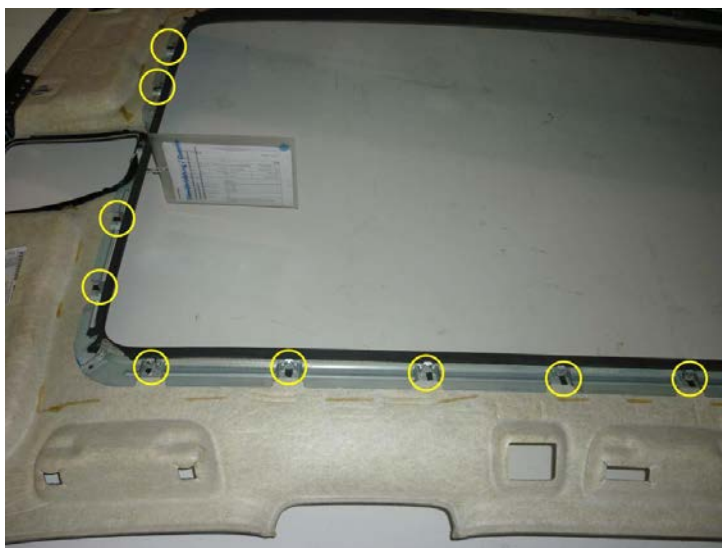
*Figure 1. Location of the headliner to sunroof frame clips.*

1. Test drive the vehicle (preferably with the customer) and duplicate the noise. Applying pressure to areas of the headliner around the perimeter of the sunroof will eliminate the noise, confirming the root cause.
2. Remove the headliner. The clips shown in the illustration will need fleece adhesive tape (D 373125A2) (Figure 1).

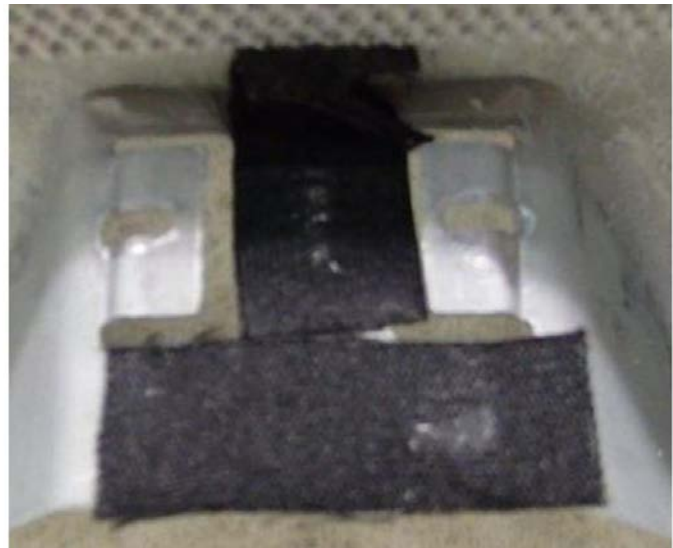
*Figure 2. Location of the fleece adhesive tape application.*

3. Remove the clips and apply the fleece adhesive tape underneath them, as shown (Figure 2).

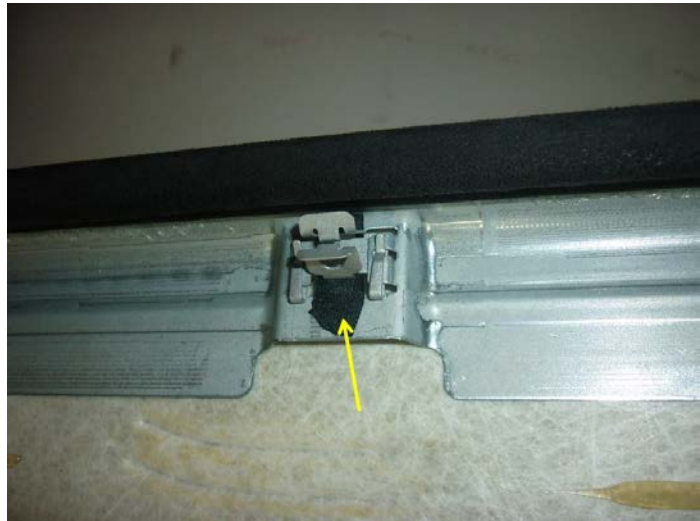
*Figure 3. Clips reinstalled.*

4. Reinstall the clips (Figure 3).

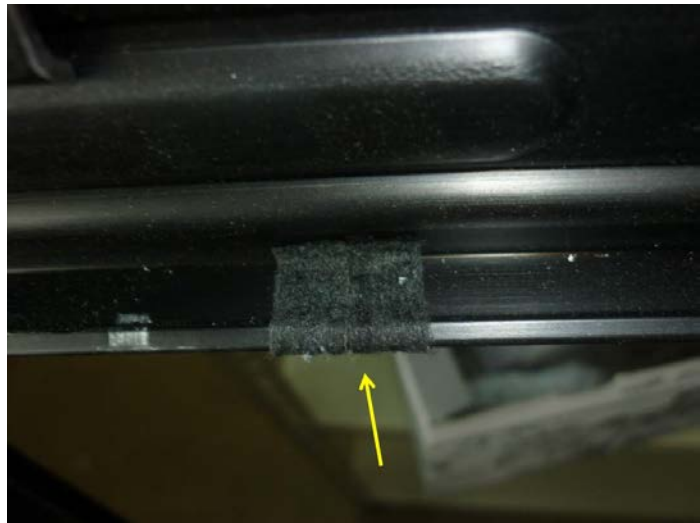
**Figure 4.** Application area on sunroof frame area of clip engagement.

- Finally, apply fleece adhesive tape to the sunroof frame lip at each clipping point (Figure 4).
